STAMP Tag Deploying Form

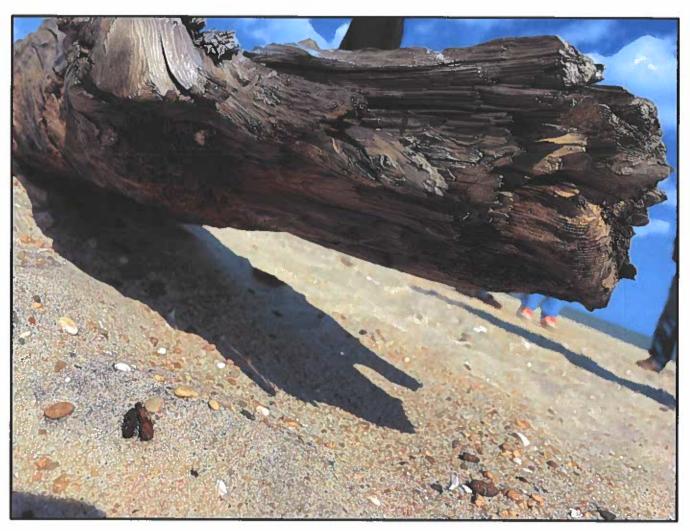
Beneath deteriorated end

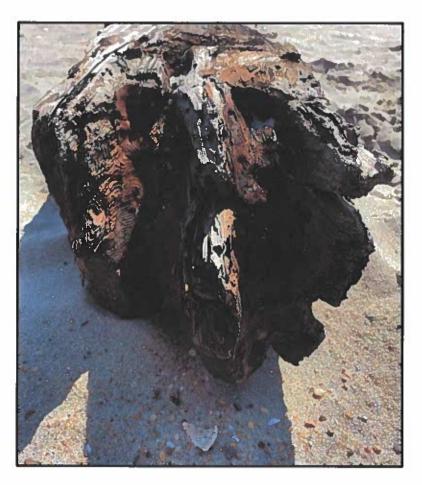
Opposite end to previous image (Left)

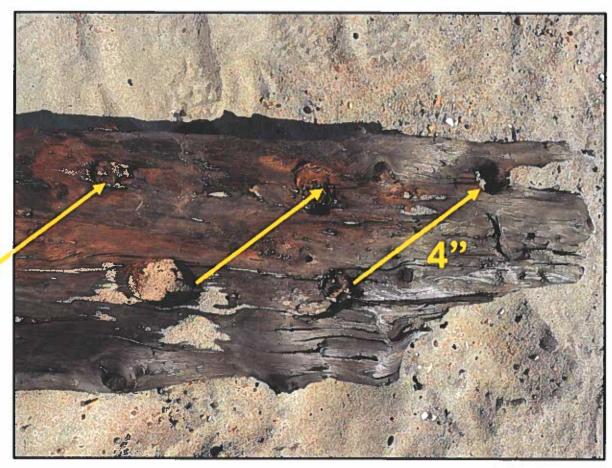
End of timber with treenails. Pattern of fasteners is on a 4" diagonal (Below)

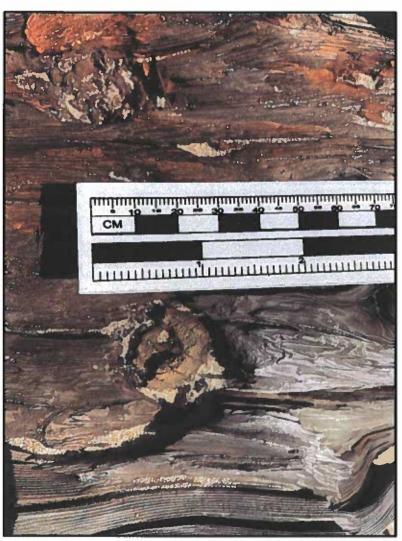
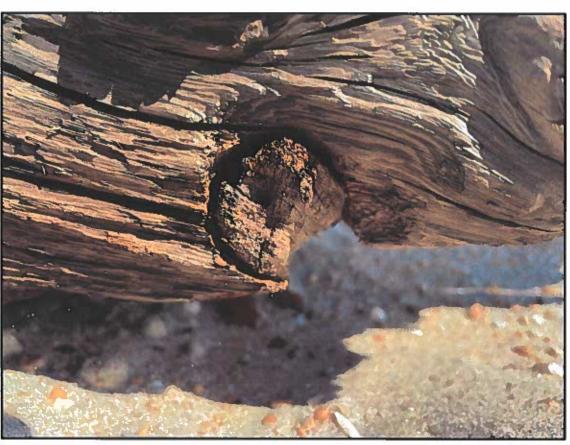
Details of treenails
