TALBOT COUNTY, MARYLAND 20TH CENTURY AGRICULTURAL CONTEXT AND HISTORIC RESOURCE SURVEY

Talbot County Historic Preservation Commission
Court House
11 North Washington Street
Easton, Maryland 21601
(410) 770-8030
2003

Mark R. Edwards, Project Manager
Fred Holycross, Architectural Historian
Amy Barnes, Architectural Historian

A county-wide thematic context for agricultural buildings and structures dating from 1900 to 1955 and a survey of fifteen (15) related historic resources was conducted by URS Corporation (URS) on behalf of the Talbot County Historic Preservation Commission and the Talbot County Council in 2003. The purpose of this project was to correct one of the deficiencies in the existing survey data for Talbot County that was noted by Paul Baker Touart in his 1992 thematic context study for the county using Certified Local Government (CLG) funds, passed through the Maryland Historical Trust (MHT).

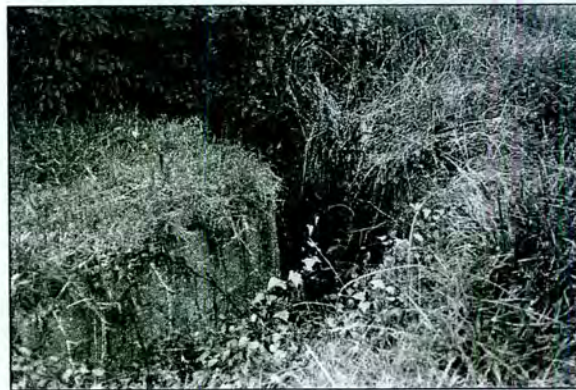
Figure 4-1: Concrete Drainage Channel

Since Talbot County has a large number of natural waterways, irrigation channels and ponds are not necessary. Some low-lying farms have retention ponds to collect run off, but most properties allowed the fields to drain naturally. Larger farms have culverts that lead to the nearest body of water. These channels were often originally constructed of poured concrete, which may have since been replaced with corrugated metal tubing. Because many drainage channels have since become buried, they may not be readily identifiable. Often the only visible portion of the channel is its mouth which is located at the bottom of an earthen ditch. Many of the drainage ditches have collapsed over time. The location of collapsed drainage ditches may be visible in aerial photographs as lines of trees and vegetation in a ditch running in between fields to a body of water.

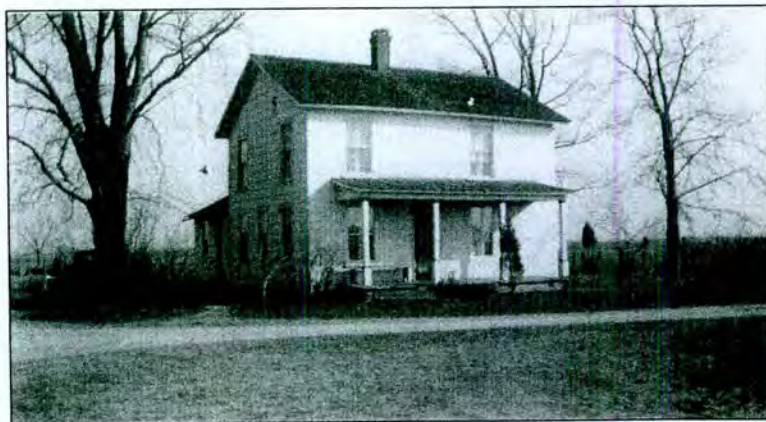
Figure 4-2: Lindemann Farm (T-391) Farmhouse, ca. 1937

The farmhouses found on twentieth-century Talbot County farms are primarily vernacular dwellings, which rarely exhibit a distinctive architectural style. Many of these were constructed in the nineteenth century and altered to accommodate changes in farming practices and domestic

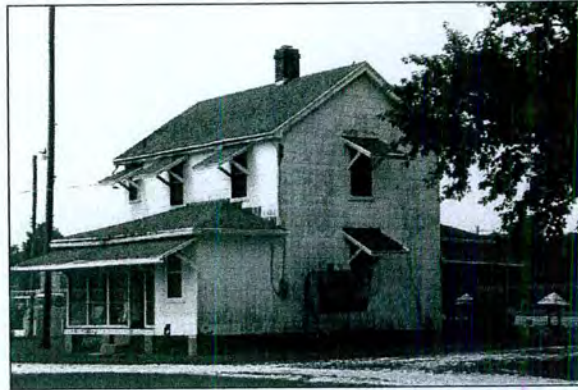
Figure 4-3: Mullikin Tenant Farm (T-390) Overseer's House, constructed ca. 1920

Overseers' houses, also known as Managers' Houses and Caretakers' Residences, are found on both gentleman's farm and industrial complexes. These residences are generally larger than a tenant house and are situated closer to the main residence. The buildings are often wood frame residential structures no more than two stories high with a hall-parlor plan. Overseers' houses frequently had their own set of outbuildings, such as hen houses, sheds and garages. In Talbot County, most overseers' houses date from the Early Twentieth-Century Stability (1900-1914), World War I (1914-1920), and the Post-War Recession, the Great Depression, and the New Deal (1920-1939) periods, though older main residences were occasionally converted into the overseers' house.

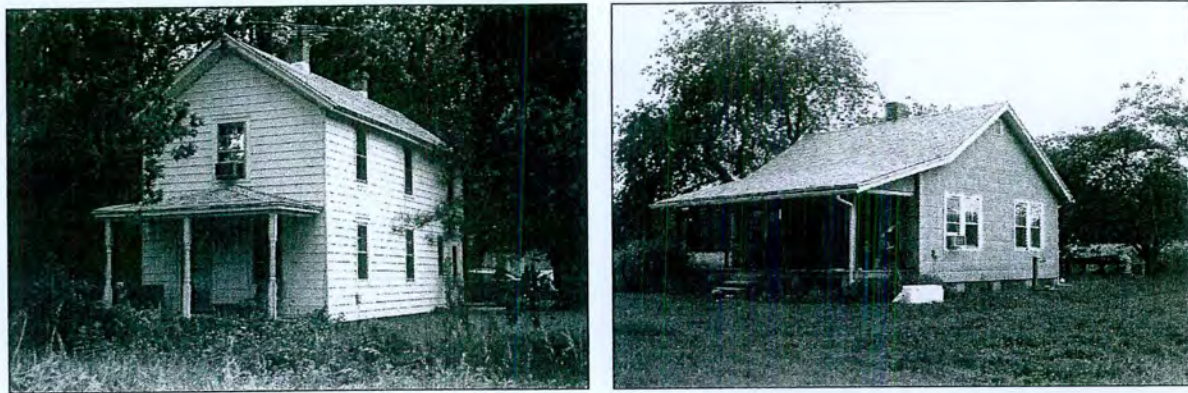
Tenant houses are found primarily in the western portions of the county as part of the gentleman's farm complexes. Many of these buildings are small wood frame residential structures no more than two stories high with a hall-parlor plan. In Talbot County these buildings frequently date from the mid-to-late nineteenth century and may have once served as the main residence for the property. When a new main residence or overseer's house was constructed, the older building was commonly converted into a tenant house. Occasional examples appear in Talbot County from the Post-War Recession, the Great Depression, and the New Deal (1920-1939) period on some Gentleman's farms as owners constructed new housing to accommodate their workers.

Figure 4-4: Chenar Farm (T-385) Tenant House Dwellings (left- a mid-to-late nineteenth-century example; right- a 1930s example)

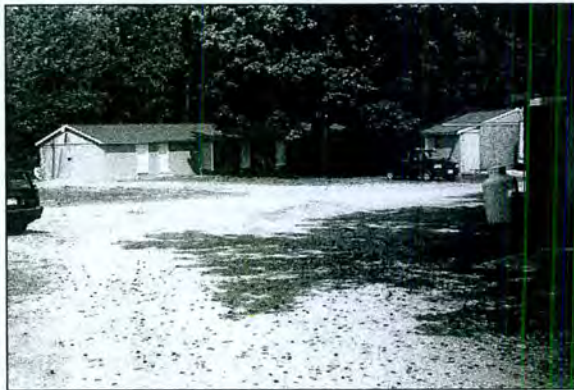
Figure 4-5: Defender Cannery (T-388) Concrete Masonry Unit Migrant Worker's Barracks, constructed ca. 1945

Extant examples of migrant worker housing are rare in Talbot County. Housing for migrant workers was constructed at farms and canneries beginning in the Post-War Recession, the Great Depression, and the New Deal (1920-1939) period for the seasonal laborers who traveled from region to region during the planting and harvesting seasons. The housing was constructed of wood or concrete masonry units with side gable roofs. There were two types of units, the individual housing, which was a separate building with a single-pen or hall-parlor plan and no fireplace, and the barracks style, which was a series of single-pen units. Both types were constructed in rows. The units had a door and a few square openings for windows. Glass was rare in early examples, but became more common as the twentieth century progressed. The interior of the building was left unfinished. Porches were occasionally constructed, expanding the available living area for the workers. Cooking took place outside or cooked food was provided, depending on the property owner. Communal privies and showers were separated from the housing and were often located to the rear of the residential area.

Migrant worker housing was constructed in Talbot County during the Post-War Recession, the Great Depression, and the New Deal (1920-1939), World War II (1939-1946), and the Post-War Boom and Industrialization of the Farm (1946-1960) periods. Extant examples are rare.

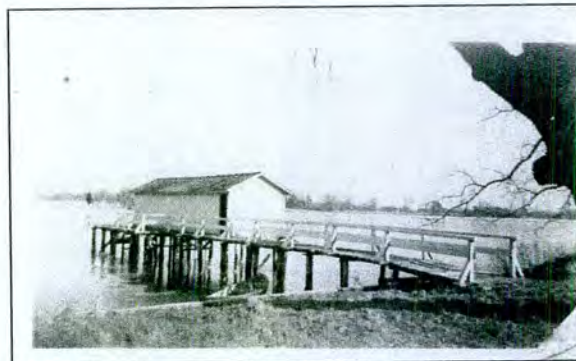
Figure 4-6: Chenar Farm (T-385) Boathouse, ca. 1942

Boathouses are one-story, single-room, rectangular structures intended to house boats. The boathouse rests on a wood pier foundation, with the piers sunk into the bottom of the waterway. The frame is of wood post and beam construction, with wood planks or board and batten siding attached directly to the horizontal framing members. The walls may have been clad with corrugated, standing-seam, and corrugated standing-seam metal panels at a later date. The side gable roof was typically clad with wood or asphalt shingles, which have since been replaced by corrugated, standing-seam, or corrugated standing-seam metal roofing. The gable end of the building that faces the water is either left open or has a set of sliding doors to allow access from the water into the interior of the building. The building is entered through a solid panel hinged door from the dock which is of wood planks on a timber frame foundation. The interior of the building was left unfinished.

Boathouse and docks are associated with the gentleman's farms located along Talbot County's waterways. They are associated with the Early Twentieth-Century Stability (1900-1914), World War I (1914-1920), the Post-War Recession, the Great Depression, and the New Deal (1920-1939), and the Post-War Boom and Industrialization of the Farm (1946-1960) periods.

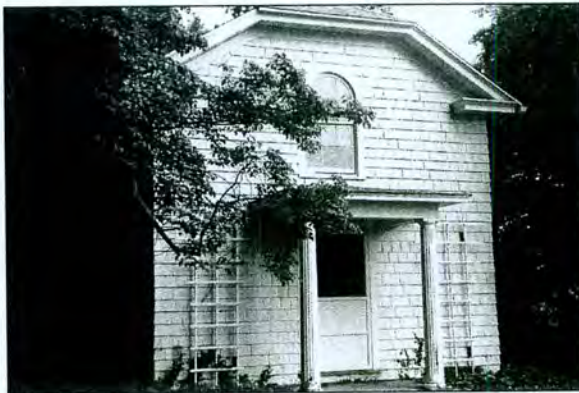
Figure 4-7: Chenar Farm (T-385) Delco House (left), constructed ca. 1923

Delco houses are small, single-room, rectangular structures intended to protect Delco (a type of early electrical equipment using an AC current) and other electrical generators from the elements. Delco houses were typically adapted to new uses and the equipment removed after the arrival of the Rural Electrification Administration (REA) in Talbot County in 1938. Delco houses are typically one-story structures situated near the main residence, which rest on a poured concrete foundation. The frame is of wood post and beam construction, with wood planks or board and batten siding attached directly to the horizontal framing members. The walls may have been clad with corrugated, standing-seam, and corrugated standing-seam metal panels at a later date. The gable roof was typically clad with wood or asphalt shingles, which have since been replaced by corrugated, standing-seam, or corrugated standing-seam metal roofing. The interior of the building is accessed through a solid panel hinged door. There are typically no windows and the interior of the building was left unfinished.

Delco houses are rare in Talbot County as electrical equipment was purchased only by those farmers who could afford it and many did not survive after rural electrification. Delco houses were constructed in the county during the World War I (1914-1920), and the Post-War Recession, the Great Depression, and the New Deal (1920-1939) periods.

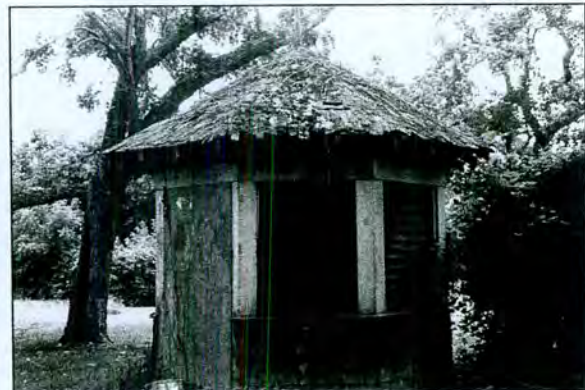
Figure 4-8: Chenar Farm (T-385) Gas House (right), constructed ca. 1922

Gas houses are of similar construction with the exception that they were intended to protect gas jets and small coal gasification plants from the elements. Gas houses are also rare in Talbot County as the equipment was purchased only by those farmers who could afford it and many of these buildings did not survive after rural electrification. Gas houses were constructed in the county during the Early Twentieth-Century Stability (1900-1914), World War I (1914-1920), and the Post-War Recession, the Great Depression, and the New Deal (1920-1939) periods.

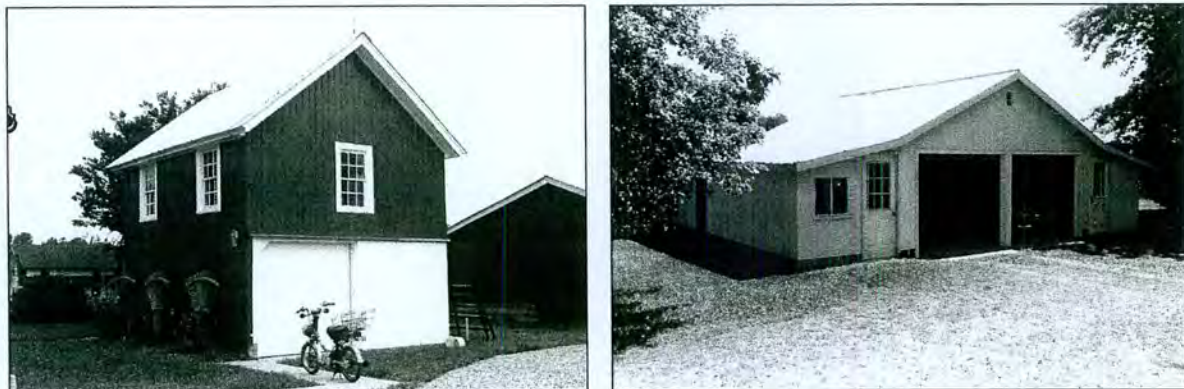
Garages are often single-room, rectangular structures intended to shelter automobiles. The garage may be a barn or carriage house converted to a garage when the farm purchased a vehicle. Garages are one-story structures which rest on a poured concrete foundation. The frame is of wood post and beam construction, with wood planks or board and batten siding attached directly to the horizontal framing members. The walls may have been clad with corrugated, standing-seam, and corrugated standing-seam metal panels at a later date. The gable roof was typically clad with wood or asphalt shingles, which have since been replaced by corrugated, standing-seam, or corrugated standing-seam metal roofing. One side wall is either left open or has one or more sliding or swinging garage doors to allow vehicular access to the interior. Most garages have a secondary entrance through a solid panel hinged door. The interior of the building was typically left unfinished. A portion of the interior was generally set aside as a workshop and/or storage space for the farmer. In some cases, one or more side additions to the garage were constructed to accommodate the workshop and storage spaces.

Figure 4-9: Garages (left- Mullikin Farm [T-389] example, constructed ca. 1910; right- Lindemann Farm [T-391] example, constructed ca. 1957)

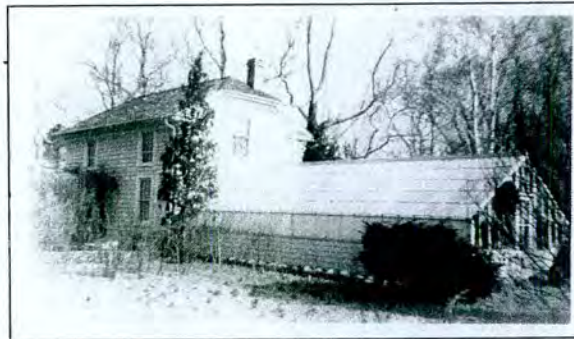
Figure 4-10: Chenar Farm (T-385) Greenhouse, ca. 1942.

Greenhouses are single-room, rectangular structures intended to regulate the temperature and humidity of the environment for the cultivation of delicate or out-of-season plants and crops. In the twentieth century, many greenhouses were pre-fabricated frame structures. Greenhouses are one-story structures which rest on a poured concrete or concrete masonry unit foundation. The frame is of wood or metal, with the space in between the panels filled with large sheets of glass. The low-pitch front-gable roof is also constructed of wood or metal framing with glass panels. The interior of the building is accessed through a solid panel hinged door. The interior of the building was typically left unfinished.

Greenhouses in Talbot County are rare as they were constructed solely for personal use and were never used as part of the development of the county's agriculture. They are often associated with gentleman's farms during the Early Twentieth-Century Stability (1900-1914), World War I (1914-1920), the Post-War Recession, the Great Depression, and the New Deal (1920-1939), and the Post-War Boom and Industrialization of the Farm (1946-1960) periods.

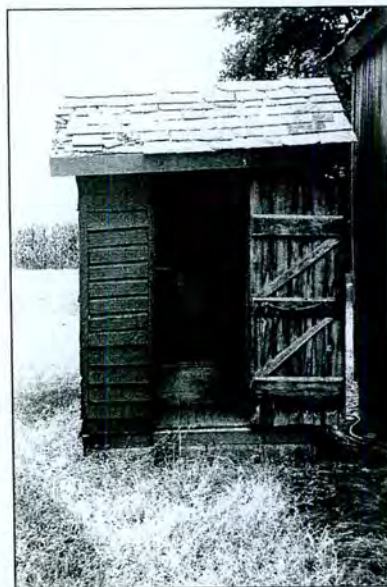
Figure 4-11: Clarke W. Sewell Farm (T-393) Wood Frame Privy, constructed ca. 1920

Privies are narrow, single-room, rectangular structures located away from the residence to avoid odors, but close enough to be reached in poor weather. The residential privy rests on a poured concrete or concrete masonry unit pier foundation. The frame is of wood post and beam construction, with wood planks or board and batten siding attached directly to the horizontal framing members. The walls may have been clad with corrugated, standing-seam, and corrugated standing-seam metal panels at a later date. The shed roof was typically clad with wood or asphalt shingles, which have since been replaced by corrugated, standing-seam, or corrugated standing-seam metal roofing. Usually, the building has either a roof ventilator or a series of horizontal openings at the roof line to allow for ventilation. The building is entered through a solid panel hinged door. Occasionally, the doors had decorative cutouts. The interior of the building was typically left unfinished with a boxed portion covered with wood planks with a hole cut in the planks.

This building type first appeared in Talbot County during the Colonial Period. Existing privies are rare in Talbot County and surviving examples were constructed primarily during the Early Twentieth-Century Stability (1900-1914), World War I (1914-1920), and the Post-War Recession, the Great Depression, and the New Deal (1920-1939) periods, prior to the introduction of indoor plumbing on the farm.

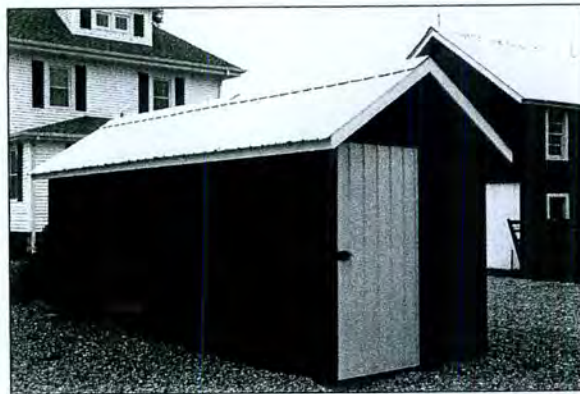
Figure 4-12: Mullikin Farm (T-389) Pump House, constructed ca. 1915

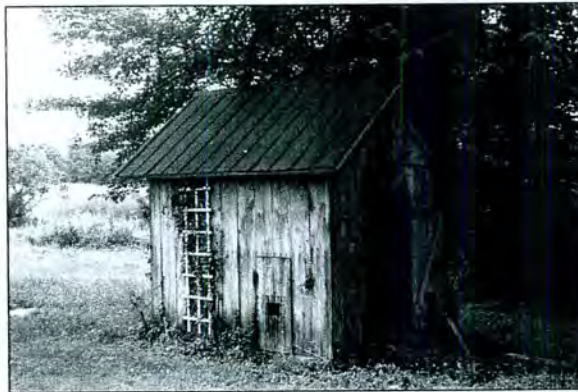
Figure 4-13: Chenar Farm (T-385) Smokehouse, constructed ca. 1900

Smokehouses are small, single-room, rectangular structures intended to house meat during the smoking and curing process. Smokehouses were typically adapted to new uses after the decline of farm self-sufficiency. They are one-story structures situated near the main residence or barn, and can rest on either a pier or continuous masonry foundation. The frame is of wood post and beam construction, with wood planks or board and batten siding attached directly to the horizontal framing members. The walls may have been clad with corrugated, standing-seam, and corrugated standing-seam metal panels at a later date. The front-gable roof was typically clad with wood or asphalt shingles, which have since been replaced by corrugated, standing-seam, or corrugated standing-seam metal roofing. Ventilators are located in the gable ends or along the roofline to allow the smoke to create a draw and allow smoke to escape. The interior of the building is accessed through a solid panel hinged door. There are typically no windows and the interior of the building was left unfinished with an earthen floor.

This building type first appeared in Talbot County during the Colonial Period. Smokehouses are rare in Talbot County as the home preservation of meat declined rapidly during the twentieth century. Smokehouses were constructed in the county during the Early Twentieth-Century Stability (1900-1914), World War I (1914-1920), and the Post-War Recession, the Great Depression, and the New Deal (1920-1939) periods.

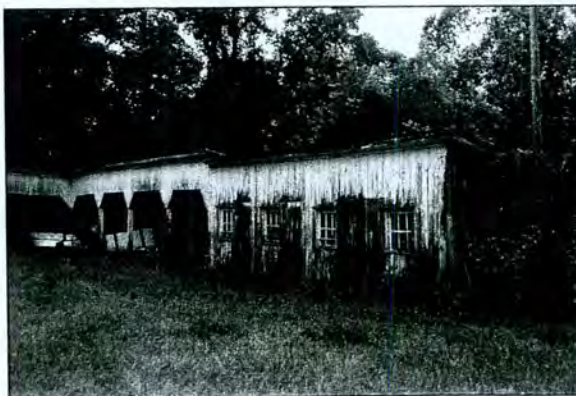
Stables are rare as most examples were converted into garages or machinery sheds. Stables were constructed primarily on larger farms in Talbot County during the Early Twentieth-Century Stability (1900-1914), World War I (1914-1920), the Post-War Recession, the Great Depression, and the New Deal (1920-1939), and the World War II (1939-1946) periods.

Figure 4-14: Chenar Farm (T-385) Stable Exterior (left), constructed ca. 1920

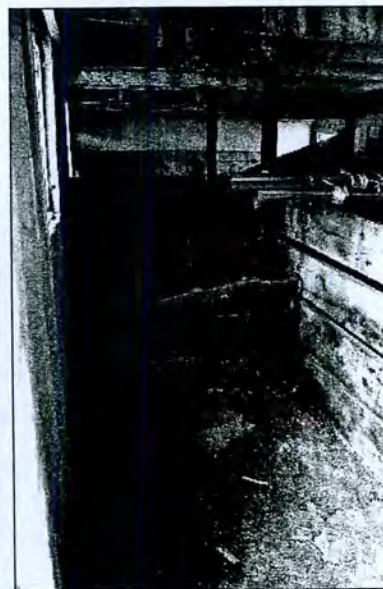
Figure 4-15: Langdon (T-215) Stable Interior (right), with Feed Bin, constructed ca. 1910

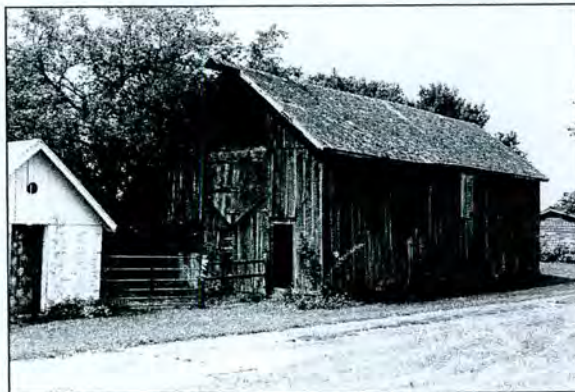
The majority of the barns built in Talbot County throughout the twentieth century are Transverse Crib, or Aisled Barns. This barn type is commonly one-and-a-half to two-stories high with a hayloft located in the attic space. The building is entered through either of the gable ends, usually through a pair of large swinging or sliding doors. A central aisle runs down the length of the barn with at least three bays on either side. This type is ideal for multi-purpose barns because it is easy to construct and lends itself to versatility. The central passageway could be used for threshing or machinery storage while the side bays could accommodate animals and other storage. These barns were frequently adapted for machinery use and storage as animal use declined on the farms.

Figure 4-16: Country Rectory (T-387) Transverse Crib Barn, constructed ca. 1920

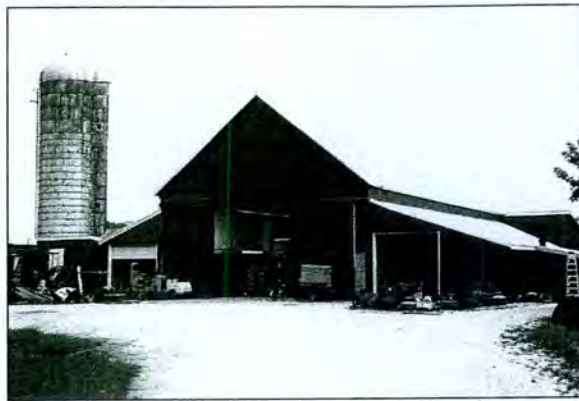
Figure 4-17: Mullikin Tenant Farm (T-390) Gable Roof Barn with Side Shed Roof Additions, constructed ca. 1910

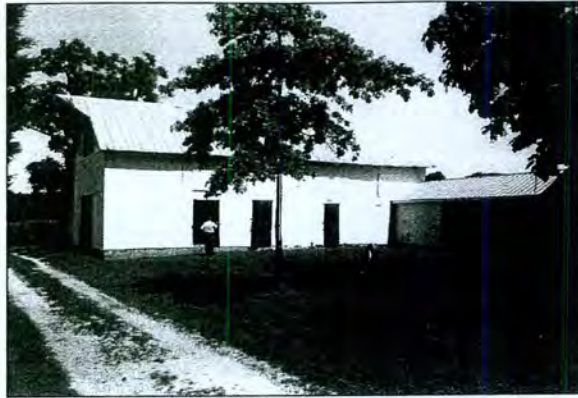
Figure 4-18: Lindemann Farm (T-391) Barn with a Hay Hood, constructed ca. 1900

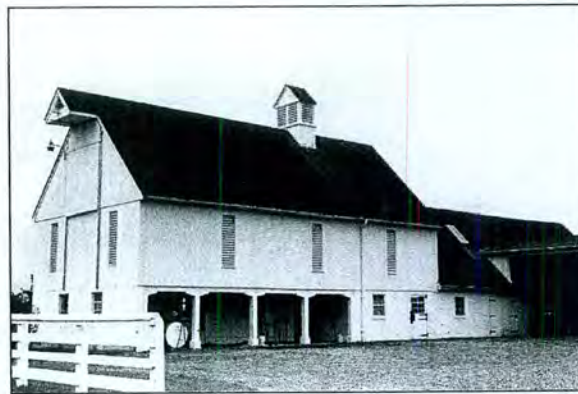
Hay hoods are found on some barns in Talbot County, though they are uncommon. Hay hoods are roof extensions located at the ridge of the roof which are used to support and protect the pulleys used to load hay into the loft space. They can also be used to shelter the loft door from weather. They are most commonly found on barns with gable-end loft openings, such as the aisled barn.

Figure 4-19: Langdon (T-215) Barn with Ventilators and a Hay Hood, constructed ca. 1939

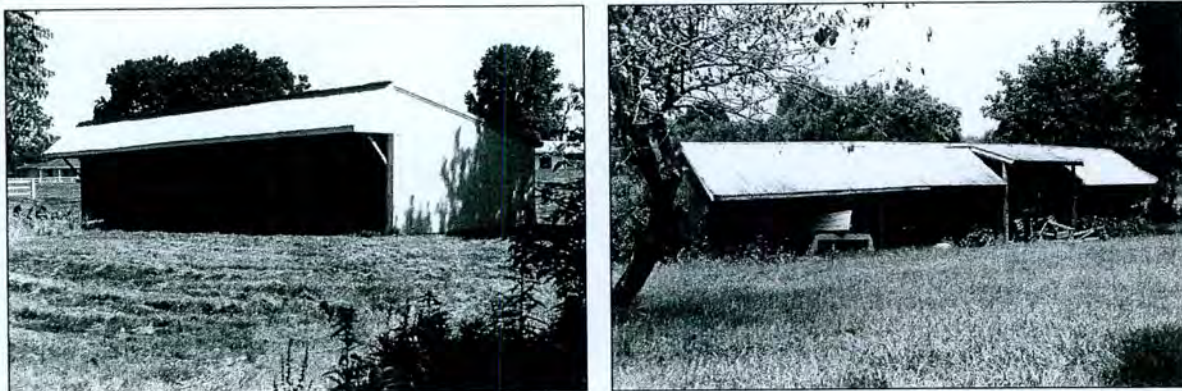
This building type is also found as a pre-fabricated metal frame structure. Pre-fabricated examples are clad with clad with corrugated, standing-seam, and corrugated standing-seam metal panels and are later in date than wood frame examples, dating from the Post-War Boom and Industrialization of the Farm (1946-1960) period to the modern day.

Figure 4-20: Machinery Sheds (left- Radcliffe Manor [T-42] example, constructed ca. 1935; right- Schofield House [T-342] example, constructed ca. 1935)

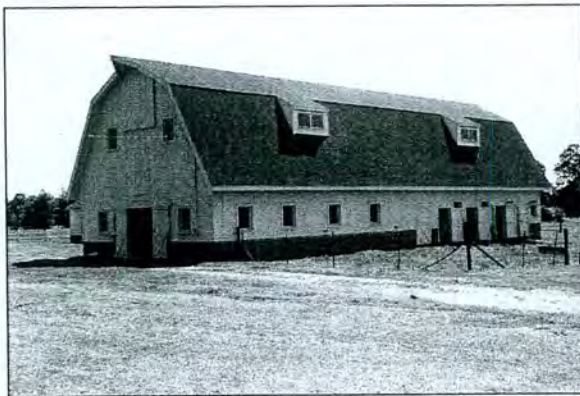
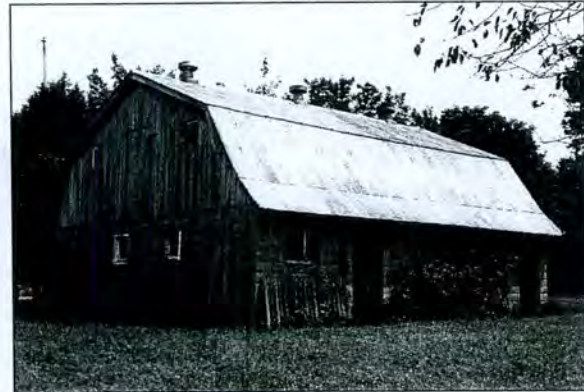
Doors and windows were also used to increase building ventilation and are found on all building façades. Large sliding doors are located on the gable ends, with hinged hay loft doors above. Smaller doors for humans are either single panels or Dutch doors. Dutch doors were preferred for dairy buildings as they restricted animal movement, but still allowed light and ventilation into the building. A large number of regularly spaced windows for light and ventilation are the single-most defining characteristic of dairy barns. In Talbot County, these windows were wood frame hopper or awning sashes. They have occasionally been replaced with fixed metal or vinyl frame windows.

Figure 4-21: Dairy Barns (left- Radcliffe Manor [T-42] example, constructed ca. 1935; right- Schofield House [T-342] example, constructed ca. 1935)

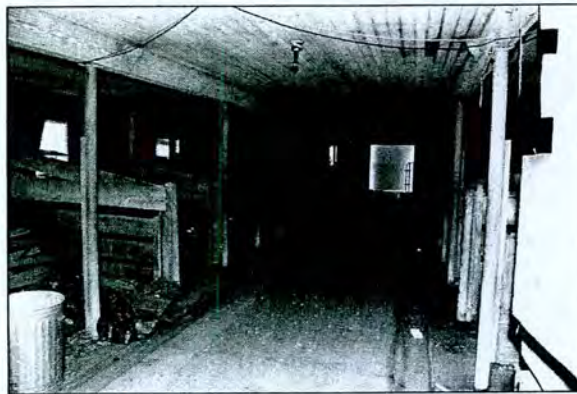
The interior of the building was left unfinished. In order to meet the increasingly stricter sanitary regulations in the twentieth century, these buildings had a poured concrete floor, which had a channel cut into it on either side of the aisle. These channels allowed for easy drainage of animal wastes from the interior. The interior pens were originally constructed of wood planks and framing. After World War II, dairy operations replaced the wooden pens with stanchions made of tubular steel. Milking machinery was located in a portion of the dairy barn. The stainless steel bars and machines were frequently placed on top of a one-foot concrete curb.

Figure 4-22: Radcliffe Manor (T-42) Dairy Barn Interior with Stalls, a Concrete Floor, and Drainage Channels, constructed ca. 1935

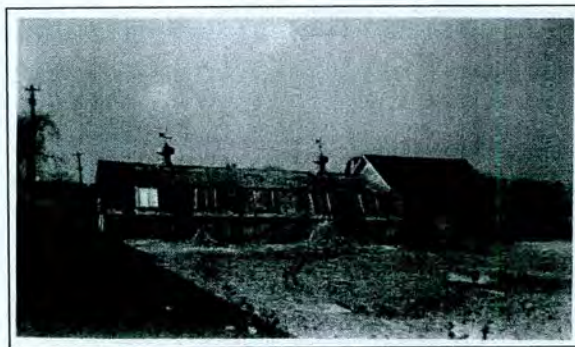
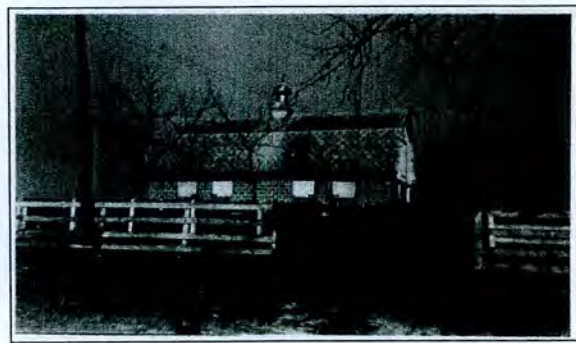
Large Talbot County dairy operations occasionally had a series of specialized barns. On these farms there could be bull barns, maternity barns, and milking parlors in addition to the main dairy barn. These barns were often constructed using the same shape, roof form, materials and construction methods as the multi-purpose and dairy barns in the county. Existing examples of these types of operations are rare in the county.

Figure 4-23: Chenar Farm (T-385) Specialized Barns, ca. 1942 (left- the Calf Barn; right- the Bull Barn).

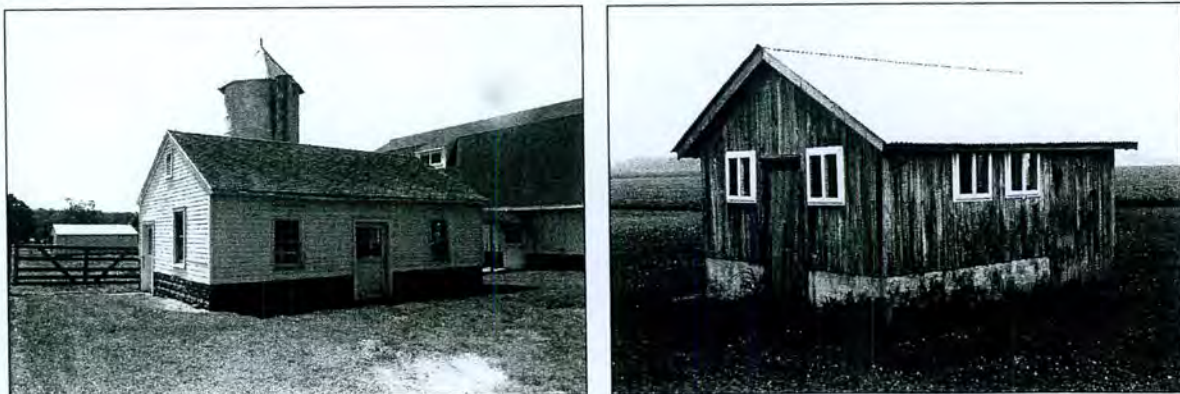
Milk houses are most common in the central and northern parts of Talbot County, where the local dairy industry was located. Talbot County milk houses date from the Post-War Recession, the Great Depression, and the New Deal (1920-1939) and the World War II (1939-1946) periods.

Figure 4-25: Milk Houses (left- Radcliffe Manor [T-42] example, constructed ca. 1935; right- Voshell Farm [T-395] example, constructed ca. 1935)

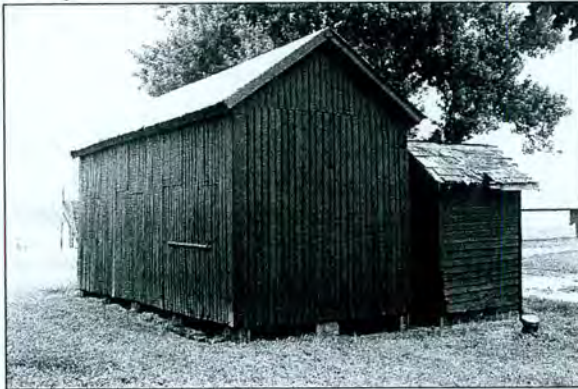
Corncribs are long, narrow, rectangular structures designed to provide the maximum air circulation possible for drying unshelled ears of corn. The building was raised off the ground in order to promote the drying process and to protect the corn from rodents, livestock, and moisture. The building is typically one-story high and of wood frame construction on a raised concrete, concrete masonry unit, or brick pier foundation. The floor of the corncrib is of wood planks with no more than three inches of space between the boards. The walls are clad with spaced vertical wood planks. The roof is typically a front-gable, though shed roof examples are known to occur in the region. The roof was typically clad with wood or asphalt shingles, which have since been replaced by corrugated, standing-seam, and corrugated standing-seam metal roofing. The hinged loading door is typically located on the gable end and is of wood boards with the same spacing as the walls. Corn was kept away from the door opening by a temporary wall of boards set in vertical grooves in the wall. The boards could be removed as needed to access or load the corn. Traces of this temporary wall are often difficult to locate due to its transient nature and property owners adapting the building to new uses. The more elaborate examples of this building type have two corncribs connected by a common roof. The space between the buildings was left open to accommodate wagons and other vehicles. The interior of the building was left unfinished.

Figure 4-26: Clarke W. Sewell Farm (T-393) Corncrib (left), constructed ca. 1920

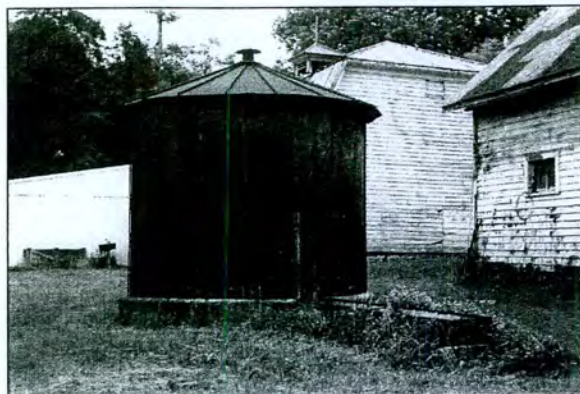
A variation of the timber frame corncrib is the pre-fabricated metal frame circular corncrib. The circular corncrib is one-story high and of metal frame construction on a poured concrete slab. The walls are constructed of wire mesh or pierced metal panels. The wall materials allowed for maximum drying capability with the wide diameter of a round structure. The roof is conical and clad with standing-seam metal. The interior of the structure was left unfinished. This variation of

Figure 4-28: Chenar Farm (T-385) Pre-Fabricated Metal Corncrib, constructed ca. 1920

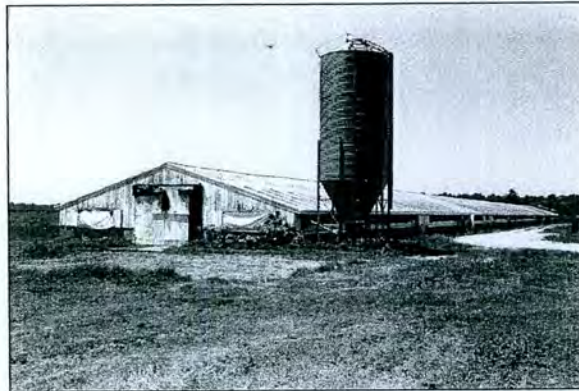
Grain bins in Talbot County are commonly associated with the poultry industry due to the need to store corn for the poultry. Grain bins were originally located adjacent to the broiler house or hatchery (see Section 4.10), and were later attached to the buildings. Most grain bins measure eight to sixteen feet in diameter, with a height of twelve to twenty-five feet and rest on poured concrete slab foundations. Grain bins are constructed of corrugated metal panels, which are bolted onto a rigid steel frame. The bottom of the grain bin is tapered into a funnel shape and is constructed of smooth metal panels. The roofs have a hemispherical form and are also constructed of smooth metal panels. An access hatch is located at the top of the bin, and is accessed via a metal ladder attached to the outside of the structure. Feed is dispensed from the bottom of the grain bin into the buildings through the use of metal pipes and a timed pressurized system. The interior of the structure was left unfinished.

Figure 4-29: Poultry Farm at 30090 Lloyds Landing Road (T-392) Grain Bin Adjacent to a Broiler House, constructed ca. 1950

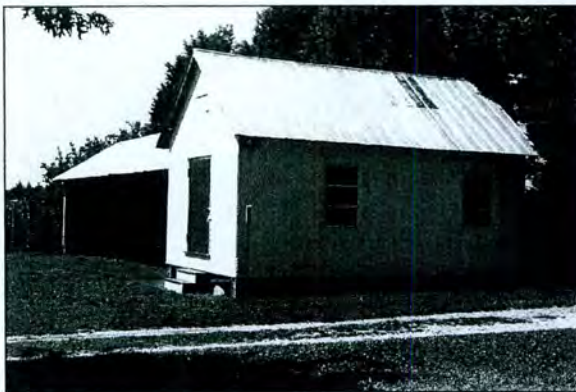
Granaries are small rectangular structures designed for storing small grains such as wheat, barley, and oats. The building was raised off the ground in order to protect the grain from rodents, livestock, and moisture. The Talbot County granary is typically one-story high and of wood frame construction on a raised concrete, concrete masonry unit, or brick pier foundation. Metal disks or other barriers intended to help keep animals out are occasionally found where the piers meet the sills of the building. The floor of the granary is of wood planks placed tightly together. The walls are clad with vertical wood planks in Talbot County. The front-gable roof was typically clad with wood or asphalt shingles, which have since been replaced by corrugated, standing-seam, and corrugated standing-seam metal roofing. There are no openings into the building other than the hinged loading door, which is typically located on the gable end and is of wood boards. The interior space would have been divided into bins to separate the various types of grain, though these dividers have often been removed due to property owners adapting the building to new uses. The interior of the building was left unfinished.

Figure 4-30: Lindemann Farm (T-391) Granary, constructed ca. 1940 with windows added at a later date

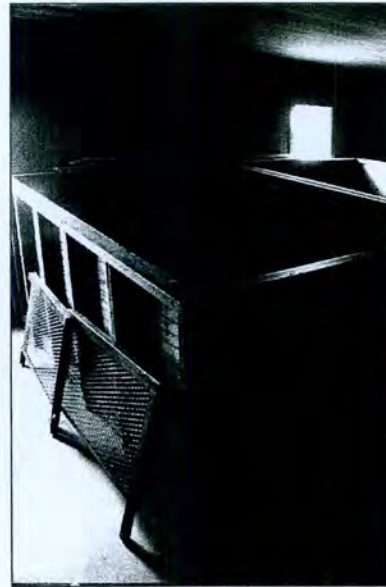
Figure 4-31: Langdon (T-215) Grain Bin, constructed ca. 1930

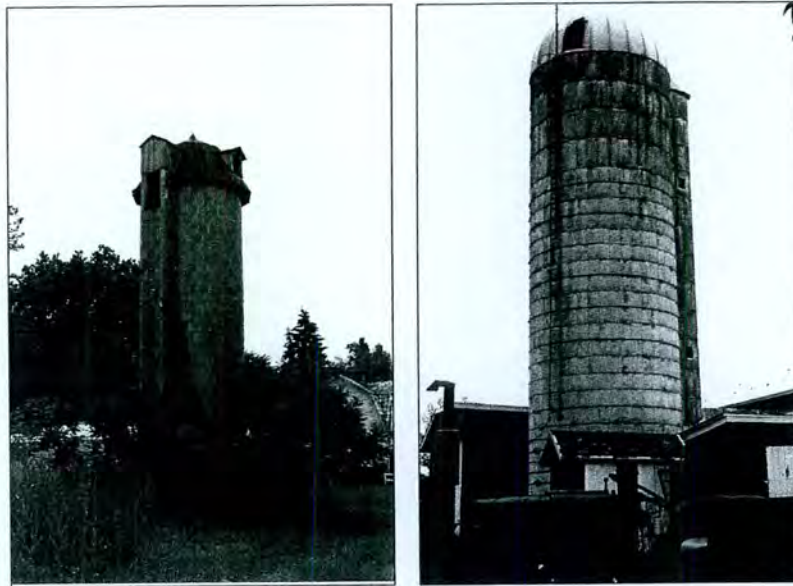
Figure 4-32: Chenar Farm (T-385) Tile Masonry Silo with a Hipped Roof (left), constructed ca. 1910

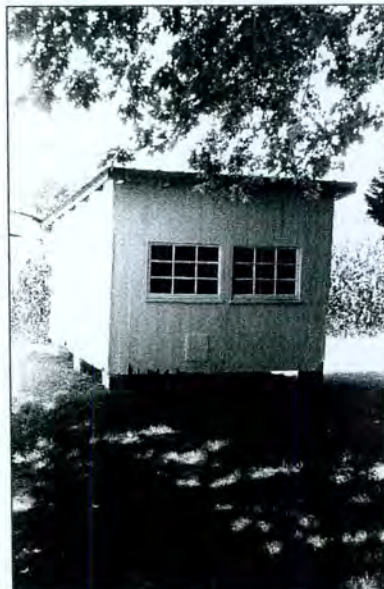
Large horizontal window openings and solid panel hinged doors are found along on side wall, usually the one with the southernmost exposure. A set of smaller openings can occasionally be found along the opposite site wall. Originally, these openings had top or bottom hinged wood and/or screen panels that allowed for ventilation. The majority of the openings have since been boarded up or have had glass installed. The interior of the building was typically left unfinished, with wood paneling extending up approximately three feet from the finished floor level to aid in containing the poultry and waste. Wood nesting boxes were attached to the rear wall. In most cases, the nesting boxes have been removed due to property owners adapting the building to new uses.

Figure 4-35: Lindemann Farm (T-391) Hen House, constructed ca. 1937

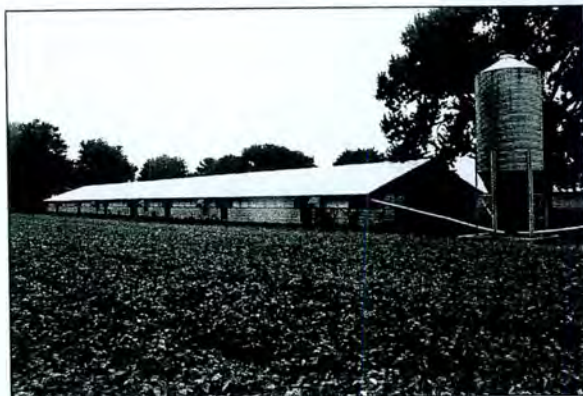
Broiler houses are most common in the central and southern parts of Talbot County, where the local poultry industry was located. Talbot County broiler houses date from the Post-War Recession, the Great Depression, and the New Deal (1920-1939), the World War II (1939-1946) and the Post-War Boom and Industrialization of the Farm (1946-1960) periods.

Figure 4-36: Clarke W. Sewell Farm (T-393) Broiler House with Adjacent Grain Bin, constructed ca. 1935

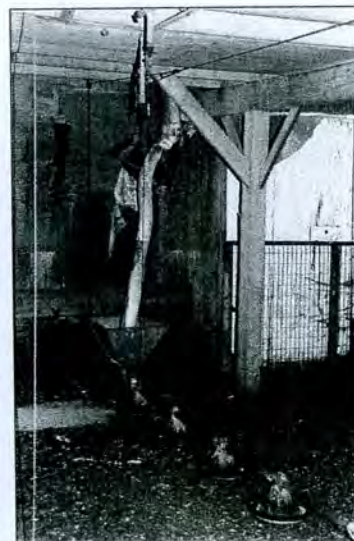
Large horizontal window openings and solid panel hinged doors are found along the side walls, with doors interspersed at regular intervals. Originally, these openings had top or bottom hinged wood and/or screen panels that allowed for ventilation. The majority of the openings have since been boarded up. Large sliding doors are located on the gable ends of the building. The interior of the building was typically left unfinished. Poultry were fed and watered through a series of metal pipes that ran the length of the building. Regularly spaced circular metal feeders were connected by the pipes and food was dispensed via a timed system from the grain bin located next to the building (see Section 4.8). Water ran through the pipes located on either side of the feeders. This feed and water system was located on either side of the wood posts.

Figure 4-37: Poultry Farm at 30090 Lloyds Landing Road (T-392) Automated Feeding and Watering System

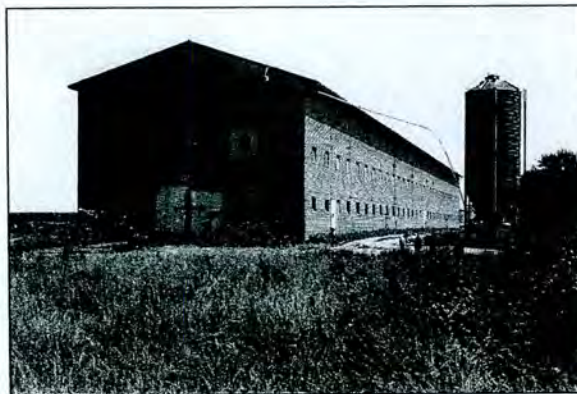
Hatcheries are most common in the central and southern parts of Talbot County, where the local poultry industry was located. Talbot County hatcheries date from the Post-War Boom and Industrialization of the Farm (1946-1960) period.

Figure 4-39: Poultry Farm at 30090 Lloyds Landing Road (T-392) Hatchery, constructed ca. 1960

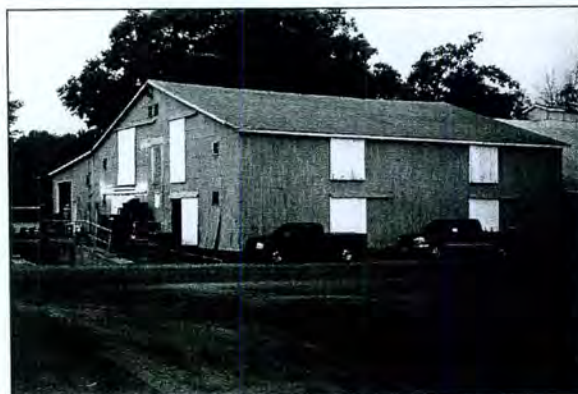
The interior of the building was typically left unfinished. A simple wood stair led to the upper level storage spaces. Trap doors were located at various points in the wooden floor to allow for the movement of goods using chutes.

Figure 4-41: Defender Cannery (T-388) Cannery Building, constructed from ca. 1910 to ca. 1960

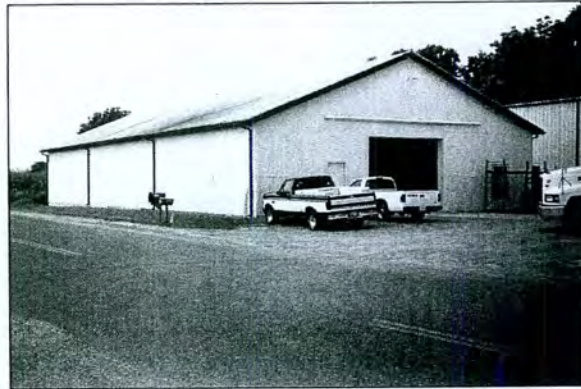
The warehouse was used for the storage of the various goods needed for canning and for storing the cannery's completed product. The building is a one-story timber frame structure with an undivided interior space. The building is three or more bays deep and rests on a continuous poured concrete foundation. The walls were clad with wood planks or board and batten siding, which may have been replaced with corrugated, standing-seam, and corrugated standing-seam metal panels. The front-gable roof was typically clad with wood or asphalt shingles, which have since been replaced by corrugated, standing-seam, or corrugated standing-seam metal roofing. The building was accessed through sliding wood plank doors. There are no windows. The interior of the building is unfinished with a poured concrete floor.

Figure 4-42: Defender Cannery (T-388) Warehouse, constructed ca. 1935

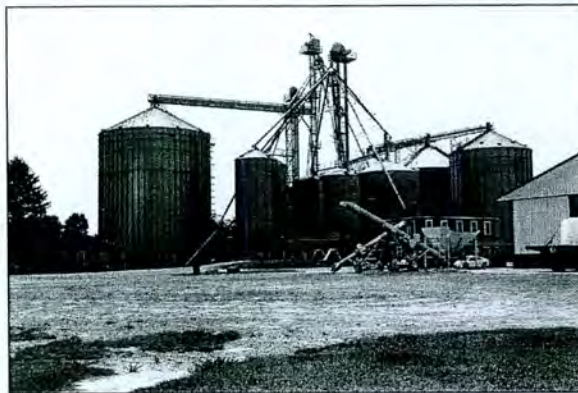
Scales were located in front of, or adjacent to, the grain elevator. The vehicle would drive onto the scale and be weighed prior to being filled with grain or seed. After being filled, the vehicle would be weighed again to determine how much product the farmer had purchased.

Figure 4-43: Wye Mills Feed Company (T-394) Grain Elevator and Grain Bins, constructed ca. 1974 to the present

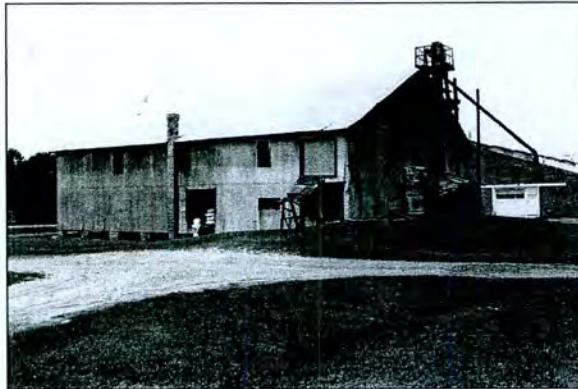
The seed house is a warehouse developed specifically for storing seed. The building is raised up off the ground, like a granary, and has a grain elevator for moving the sacks of seed. Seed houses are two-story timber frame structures with an undivided interior space. The building rests on a poured concrete or concrete masonry unit pier foundation. The walls were clad with wood planks or board and batten siding, which may have been replaced with corrugated, standing-seam, and corrugated standing-seam metal panels. The front-gable roof was typically clad with wood or asphalt shingles, which have since been replaced by corrugated, standing-seam, or corrugated standing-seam metal roofing. The building was accessed through sliding wood plank doors on all façades. Hinged wood plank doors are located on the second level to allow for easy loading and unloading of the second floor. Most seed houses had window openings to provide natural light and ventilation. The grain elevator may be located on either the interior or exterior of the building. The interior of the building is unfinished with a wood plank floor.

Figure 4-44: Wye Mills Feed Company (T-394) Seed House, constructed ca. 1960

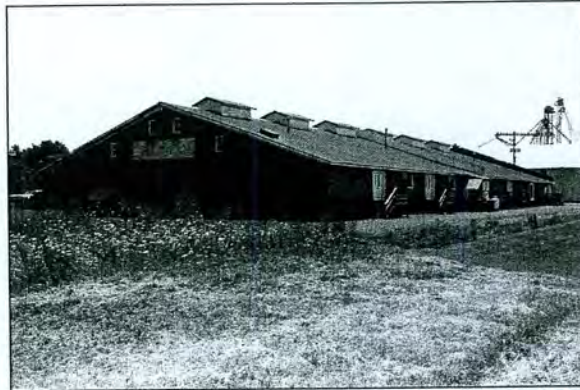
The warehouse was used for the storage of feed and grain. The building is a one-story timber frame structure with an undivided interior space. The building is three or more bays deep and rests on a poured concrete or concrete masonry unit pier foundation. The walls were clad with wood planks or board and batten siding, which may have been replaced with corrugated, standing-seam, and corrugated standing-seam metal panels. The front-gable roof was typically clad with wood or asphalt shingles, which have since been replaced by corrugated, standing-seam, or corrugated standing-seam metal roofing. The building was accessed through sliding wood plank doors. There are no windows. The interior of the building is unfinished with a wood plank floor.

Figure 4-46: Wye Mills Feed Company (T-394) Warehouse, constructed ca. 1920

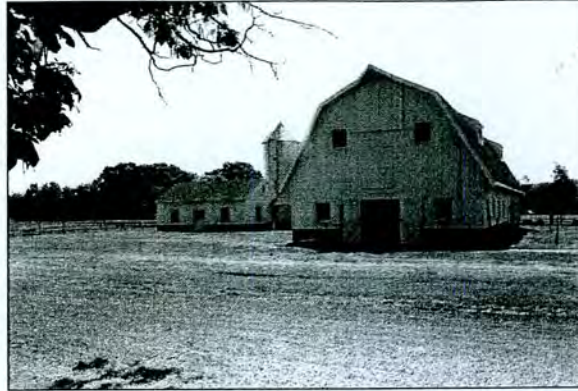
Figure 5-1: Radcliffe Manor (T-42) Dairy Complex

The property is located on a peninsula of land between the South Fork of the Avon River and Dixon Creek, to the west of the community of Easton in Talbot County, Maryland. There are twelve buildings in the dairy complex, consisting of an overseers' house, tenant house, and twentieth-century dairy complex, with a dairy barn, milk house, silo, fodder shed, hog house, chicken house, and two machinery sheds (Figure 5-1). These resources are located to the northeast of the main residence, outside of the wood post and rail fence, and along the entry drive.

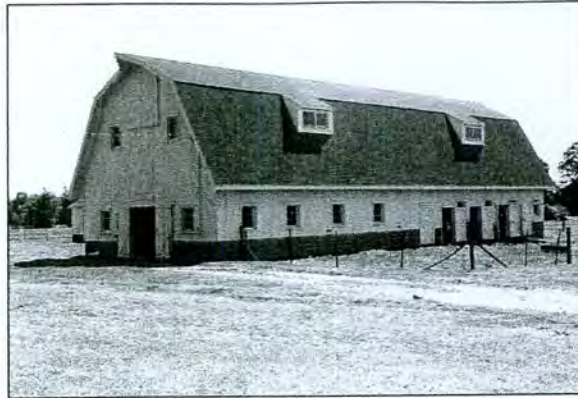
Figure 5-3: Radcliffe Manor (T-42) Dairy Barn

The main building of the complex is the gambrel-roofed dairy barn, built ca. 1935 (Figure 5-3). The barn is a two-story timber frame structure with a poured concrete slab foundation. The building is eight bays deep and has a center aisle plan with a hayloft on the second level. The gambrel roof is clad with asphalt shingles and has hay hoods on either end and four shed roof dormers. Two dormers with paired six-pane wood awning sash windows are located on each side of the roof. Eight lightning rods are located along the roof ridge.

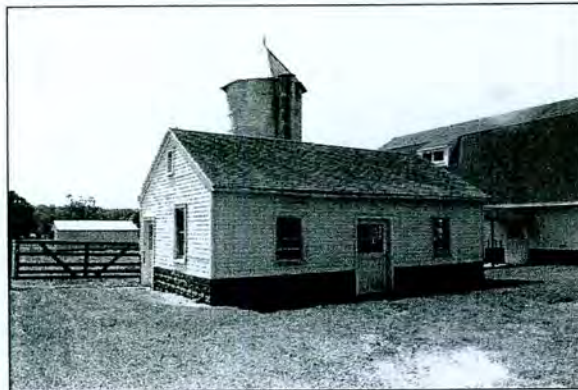
ca. 1935 milk house is a one-story light timber frame structure with an undivided interior space. The building rests on a poured concrete slab. Rusticated rock-faced concrete masonry units form the lower two-and-a-half feet of the walls. The upper portions of the walls are clad with beveled wood siding. The side gable roof is clad with asphalt shingles. The doors on the south gable end and west side wall are hinged wood plank doors with diagonal bracing and eight lights. The original windows have been replaced with one-over-one wood and six-over-six vinyl sashes which are smaller than the original windows. The interior of the building is unfinished with a poured concrete floor. The bottom three feet of the wall are clad with three inch horizontal tongue and groove beadboard.

Figure 5-4: Radcliffe Manor (T-42) Milk House and Silo

To the east of the milk house, within a fenced enclosure, is a poured concrete silo on a poured concrete pad. The silo has a conical roof clad with standing-seam metal. An enclosed metal ladder is located on the west façade. Just to the east, outside of the enclosure is a timber frame fodder shed with an open east façade. The shed rests on a combination pier and continuous poured concrete foundation. The walls are clad with board and batten siding. The side gable roof is clad with asphalt shingles. There are no doors or windows. The interior of the building is unfinished with an earthen floor.

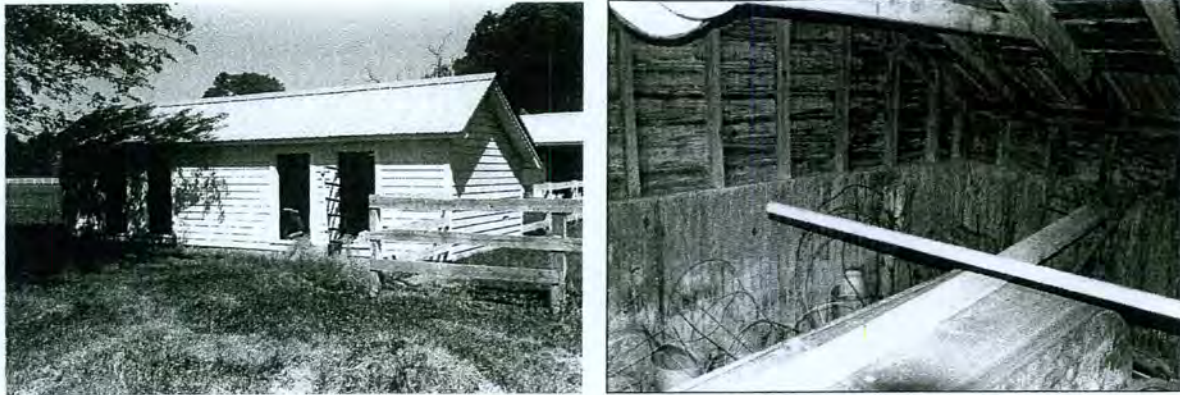
To the southwest of the dairy barn are the remainders of the agricultural buildings. The ca. 1935 hog house is located closest to the dairy barn and is a one-story light timber frame structure. The interior is divided into three rooms, one of which is an internal corn crib. A one room side addition has been constructed on the north façade. The building rests on a poured concrete slab with a one-foot curb around the perimeter. The walls are clad with beveled wood siding. The walls of the corn crib portion of the building are clad with three-foot wood planks, spaced approximately one-half-inch apart. The offset side gable roof is clad with standing-seam metal. Four exterior doors on the east and south façades are hinged plywood panels and one exterior door and the two interior doors are hinged five-panel wood. The majority of the window openings have been boarded up. Nine-pane wood awning sash windows are located on the west and south façades. The horizontal openings which flank the central entry doors on the east façade have been left open, with a single one-over-one horizontal vinyl sash used as infill. The building has an interior concrete masonry unit chimney, which is not visible on the interior. The interior of the building is unfinished with a poured concrete floor. The walls are clad with a combination of beadboard and wood planks. The ceiling is clad with the same beadboard.

Figure 5-5: Radcliffe Manor (T-42) Chicken House (left- exterior; right- interior)

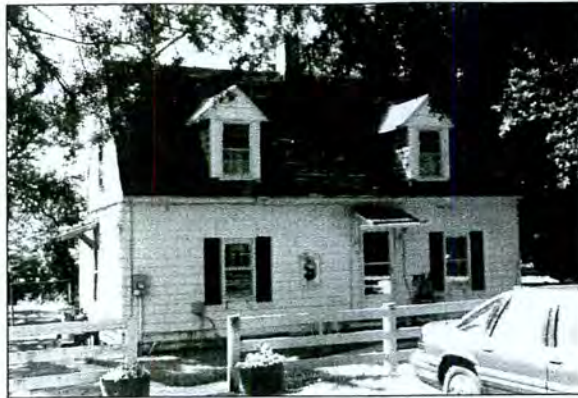
Figure 5-6: Radcliffe Manor (T-42) Tenant House

The ca. 1920 tenant house is located to the southwest of the dairy complex (Figure 5-6). The residence is a one-and-a-half story wood frame structure with a hall-parlor plan and a ca. 1960 two-story rear shed roof addition. The building rests on a continuous brick masonry foundation, with a continuous concrete masonry unit foundation on the rear addition. The building is clad with wood shingles. The side gable roof is clad with asphalt shingles and has three gable roof dormers. The central entry door is flanked by six-over-six wood sashes. The same windows are used on the ca. 1920 portion of the building. The ca. 1960 addition has one-over-one wood sashes. The building has a central brick masonry chimney. The rear porch has been enclosed with tongue and groove siding. The interior was not accessible at the time of the survey.
