TALBOT COUNTY, MARYLAND 20TH CENTURY AGRICULTURAL CONTEXT AND HISTORIC RESOURCE SURVEY

Talbot County Historic Preservation Commission
Court House
11 North Washington Street
Easton, Maryland 21601
(410) 770-8030
2003

Mark R. Edwards, Project Manager
Fred Holycross, Architectural Historian
Amy Barnes, Architectural Historian

A county-wide thematic context for agricultural buildings and structures dating from 1900 to 1955 and a survey of fifteen (15) related historic resources was conducted by URS Corporation (URS) on behalf of the Talbot County Historic Preservation Commission and the Talbot County Council in 2003. The purpose of this project was to correct one of the deficiencies in the existing survey data for Talbot County that was noted by Paul Baker Touart in his 1992 thematic context study for the county using Certified Local Government (CLG) funds, passed through the Maryland Historical Trust (MHT).

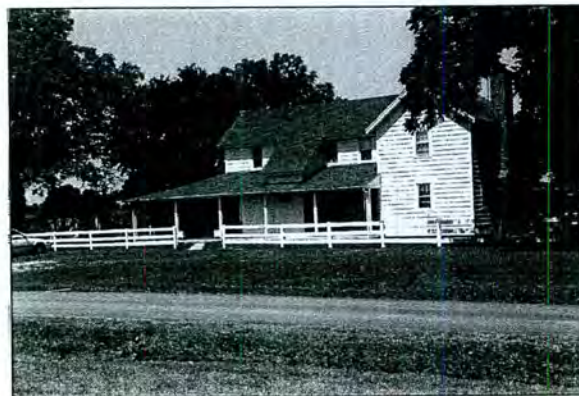
Figure 5-7: Radcliffe Manor (T-42) Overseers' House

The ca. 1910 overseers' house is located to the southwest of the dairy complex, across the access road (Figure 5-7). The residence is a two-story wood frame structure with a front facing "L"-shaped plan and a ca. 1940 front shed roof addition. The building rests on a continuous poured concrete foundation. The building is clad with horizontal wood siding and has a cross-gable roof is clad with asphalt shingles. The entry door has two wood panels with two panels of glass above. The windows are predominantly six-over-six wood sashes with a few six-pane and three-pane hopper sashes. The building has a exterior end wall brick masonry chimney. The wraparound front porch has a wood plank floor, six wood posts, and a hipped roof. A portion of the porch has been enclosed. The interior was not accessible at the time of the survey.

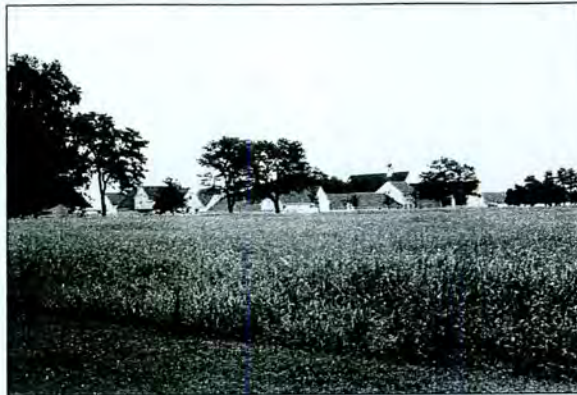
Figure 5-9: Langdon (T-215) Farm Complex

The property is located on Harris Creek, off of Tilghman Island Road to the north of Tilghman Island in Talbot County, Maryland. There are eighteen buildings on the property, consisting of the main house, the overseers’ house, a springhouse, a wood shed, a garage, a chicken house, a greenhouse, a smokehouse, a slaughter house, a storage building, a machine shed, a barn, and a long block containing a stable, a carriage house, a storage shed, a machine shed, a granary, and a corncrib. These resources are located to the west of the main residence, outside of the wood post and rail fence, off of the entry drive. A related tenant house is located on an adjacent tract of land.

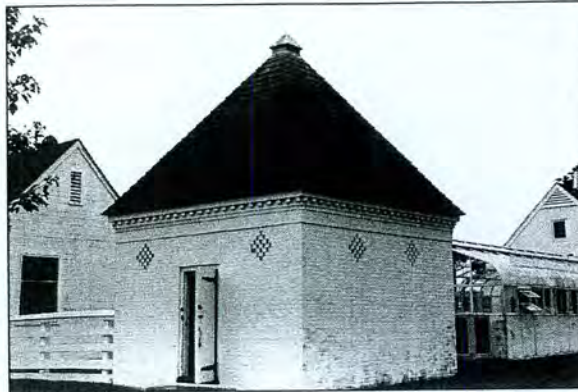
Figure 5-12: Langdon (T-215) Smokehouse

The smokehouse, constructed ca. 1930, is currently used as a recreation building (Figure 5-12). The building is a one-story brick masonry structure with an undivided interior space. The building rests on a continuous brick foundation. The walls are constructed of brick using a Flemish bond and have vents worked into the brick pattern. The pyramidal roof is clad with wood shingles and has a metal ventilator. The building is accessed through a wood plank door on the east façade. The interior of the building is unfinished with a brick floor.

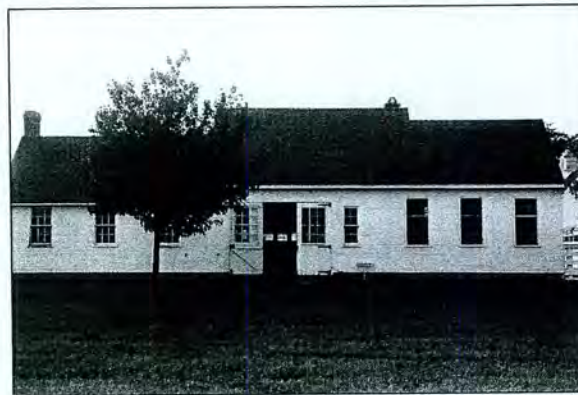
Figure 5-13: Langdon (T-215) Slaughterhouse

The slaughterhouse, constructed ca. 1930, is currently used as an office and shop (Figure 5-13). The building is a one-story light timber frame structure with a three pen plan. The building rests on a continuous concrete masonry unit foundation. The walls are clad with horizontal wood siding. The side gable roof has a steep pitch and is clad with asphalt shingles. The building is accessed through hinged wood plank doors with twelve lights on all façades and metal roll up doors into the central pen. There is an interior brick masonry incinerator chimney on the west façade. The windows are six-over-nine and eight-over-twelve wood sashes. The interior of the building is unfinished and has a poured concrete floor.

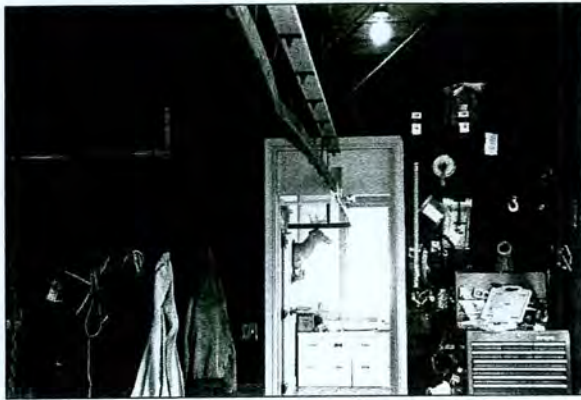
Figure 5-14: Steel Meat Rail in Langdon (T-215) Slaughterhouse (left)

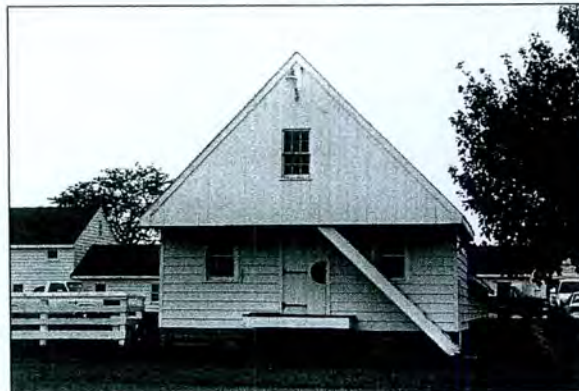
Figure 5-16: Langdon (T-215) Storage Building

The storage building, constructed ca. 1930, is a one-story light timber frame structure with an undivided interior space (Figure 5-16). The building rests on a continuous concrete masonry unit foundation. The walls are clad with horizontal wood siding. The overhanging front-gable roof is clad with asphalt shingles. The building is accessed through hinged wood plank doors on the east and south façades. A wooden loading dock is also located on the east façade. The windows are six-over-six wood sashes and six-pane wood hopper sashes. The interior of the building is unfinished and has a wood plank floor.

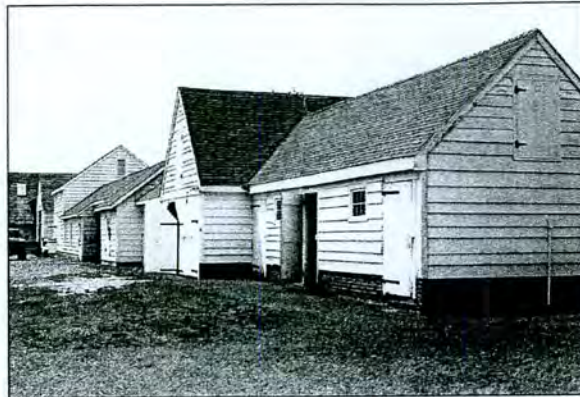
Figure 5-17: Langdon (T-215) Outbuilding Block

A machinery shed is located on the west façade of the storage building. It is five bays wide and is of timber frame construction with an open south façade. The shed rests on a combination pier and continuous poured concrete foundation. The walls are clad with horizontal wood siding. The side gable roof is clad with asphalt shingles. There are no doors or windows. The interior of the building is unfinished with an earthen floor.

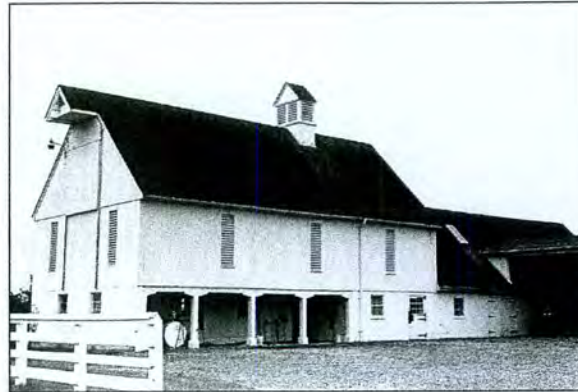
Figure 5-18: Langdon (T-215) Barn

The corncrib connects to the multi-purpose barn, constructed ca. 1939, with a rear animal pen addition (Figure 5-18). The building was significantly altered when a new access road was constructed to the east of the barn. The length of the building was shortened by 15 feet to 30 feet and the roof was replaced. The structure rests on a continuous concrete masonry unit foundation. The timber frame structure is clad with vertical wood siding. The front-gable roof is clad with asphalt shingles. The barn has a hay hood on the east gable end. The Dutch doors are hinged wood plank with diagonal bracing and twelve lights. Sliding wood plank doors are located on the gable ends. The windows are nine-pane wood hopper sashes. The interior of the building is unfinished with a poured concrete floor and metal animal pens.

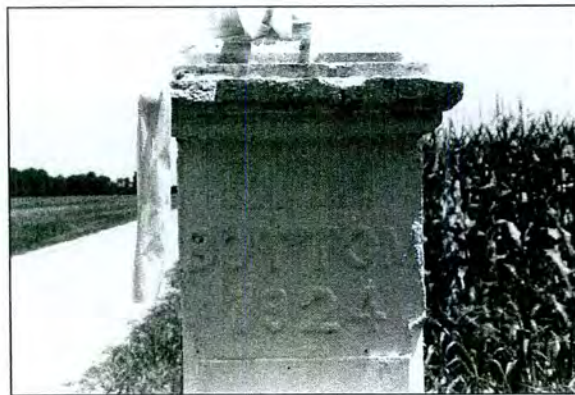
Figure 5-22: Rich Bottom (T-229) Signpost

The residence is located approximately one-quarter-mile down a straight access road with the agricultural buildings located along the access road, and the residence at the end of the access road (Figure 5-21). The outbuildings are arranged in a linear plan along the road. The property is surrounded by cultivated agricultural fields. The gravel access road is flanked by two brick columns. The southernmost column is inscribed with the words "RICH/BOTTOM/1924." (Figure 5-22) The columns have metal hinges attached, indicating that the property was once gated.

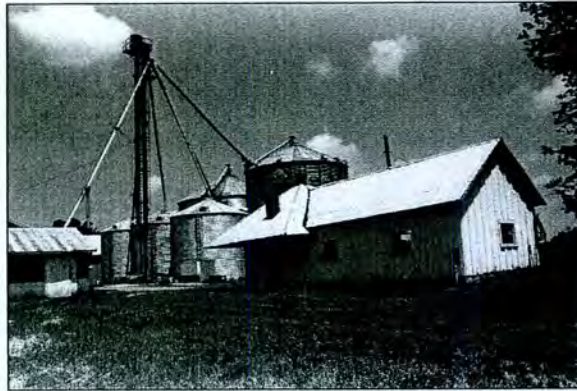
Figure 5-23: Rich Bottom (T-229) Smokehouse with Tool Shed to the Left

In addition to the previously surveyed residence, there is a smokehouse, built ca. 1900, with a shed addition on its northeast elevation located in the agricultural area (Figure 5-23). The building is a one-story timber frame structure with an undivided interior space. The smokehouse rests on a continuous brick foundation and is clad with beaded horizontal siding. The pyramidal roof has wide overhanging eaves and a metal ventilator. The roof is clad with corrugated

standing-seam metal. The building is entered through a hinged wood plank door on the southeast façade. One nine-pane wood hopper sash is located on each of the remaining façades. There is an exterior brick masonry chimney. The side addition was constructed ca. 1930 as a shed. The addition rests on a continuous poured concrete foundation. The walls are clad with board and batten siding and the building has a side gable roof clad with corrugated standing-seam metal. The addition is entered through a sliding wood plank door on the southeast façade. Five six-pane wood hopper sashes are located around the building.

The tool shed, constructed ca. 1945, is a one-story masonry structure (Figure 5-23). The building rests on a poured concrete slab and is constructed of concrete masonry units. The side gable roof is clad with corrugated standing-seam metal. The building is entered through a large hinged plywood panel door on the southwest façade. The building has eight two-over-two metal sash windows.

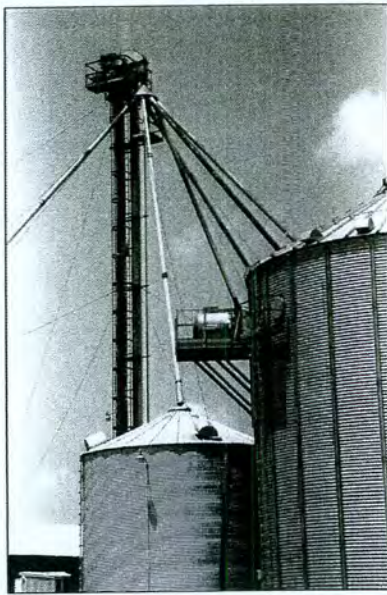
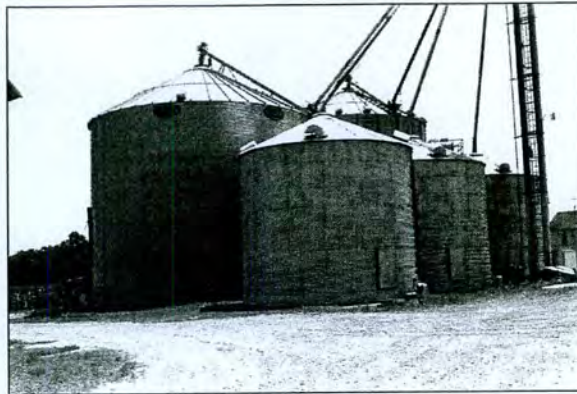
Figure 5-24: Rich Bottom (T-229) Grain Elevator (left)

The grain elevator is a modern steel structure connecting five grain bins (Figures 5-24 & 5-25). There are three small and two large grain bins. All are located on a poured concrete slab and have a steel frame. The bins are clad with corrugated metal and have conical roofs clad with standing-seam metal. Grain is inserted into the grain bins through metal hatches.

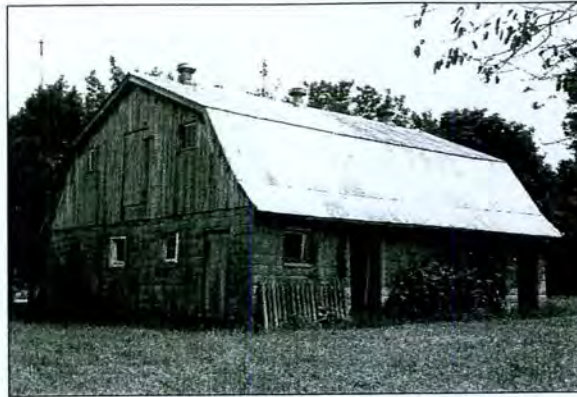
Figure 5-28: Schofield House (T-342) Barn

The main building of the complex is the gambrel-roofed dairy barn with flared eaves, built ca. 1935 (Figure 5-28). The barn is a two-story masonry structure with a continuous poured concrete foundation. The building is three bays deep and has a center aisle plan with a hayloft on the second level. The gambrel roof is clad with corrugated metal and has three metal roof ventilators.

The barn's principle entry is located on the west side wall. The walls are constructed of rusticated concrete masonry units. The building is entered through hinged wood plank doors with diagonal bracing. The windows are evenly spaced six-pane wood awning sashes.

The gable walls are also constructed of rusticated concrete masonry units. The upper portion of the wall is clad with six inch vertical wood boards. A set of hinged hayloft doors are located on the north façade. The doors are constructed of wood planks with diagonal bracing. The windows are evenly spaced six-pane wood awning sashes.

The east side wall is constructed of rusticated concrete masonry units. The building is entered through hinged wood plank doors with diagonal bracing. The windows are evenly spaced six-pane wood awning sashes.

The interior of the building is unfinished with an earthen floor. There are new wooden posts as interior supports. The second floor hayloft is an undivided space accessed via a wood ladder. The space is unfinished, with a wood plank floor and exposed trusses and framing.

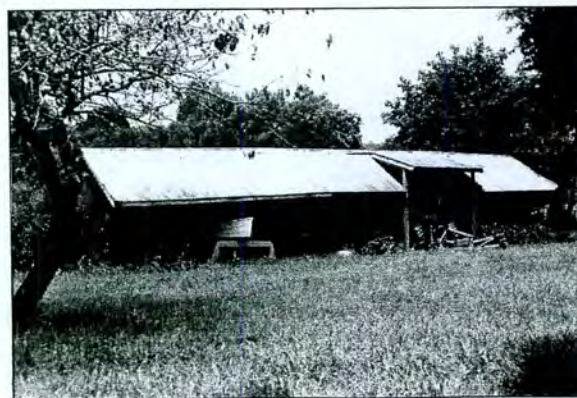
Figure 5-29: Schofield House (T-342) Machinery Shed

The machinery shed, constructed ca. 1935, is located to the south of the dairy barn (Figure 5-29). It is five bays wide and is of timber frame construction with an open north façade. The shed rests on a combination continuous poured concrete and concrete masonry unit pier foundation. The walls are clad with corrugated metal. The offset side gable roof is also clad with corrugated metal. The machinery shed has no doors or windows. The interior of the building is unfinished with an earthen floor.

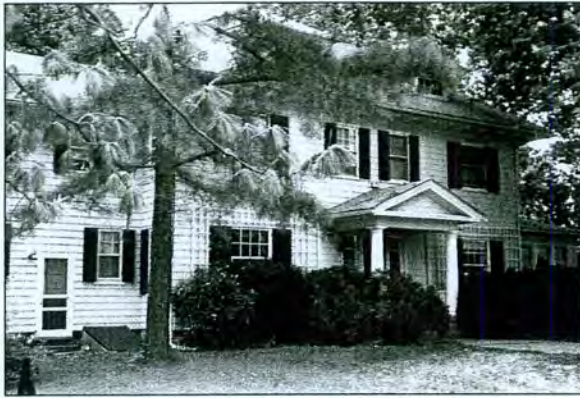
Figure 5-33: Chenar Farm (T-385) Main House, West Façade (left)

The main house is a two-and-a-half story wood frame structure with a two-story south side wing and a one-story north side wing, built ca. 1923. The residence was designed by Frank Ross, an Easton architect. The side wings are part of the original design. The building rests on a continuous brick masonry foundation and has a central passage, double-pile plan. The hipped roof with large overhanging eaves is clad with asphalt shingles and has four hipped roof dormers with 8-pane hopper sashes. Two dormers are located on each of the front and rear façades. There are two exterior end gable brick masonry chimneys.

The west façade is the principle building entry and faces the entry drive (Figure 5-33). The walls are clad with wood shingles. The building is entered through a central hinged four panel wood front door with fifteen-light sidelights. The side entry doors are hinged five panel wood doors. The windows are a combination of six-over-one and eight-over-one wood sashes. The front entry porch has a poured concrete floor, two fluted wood Doric columns, and a front-gable roof clad with asphalt shingles.

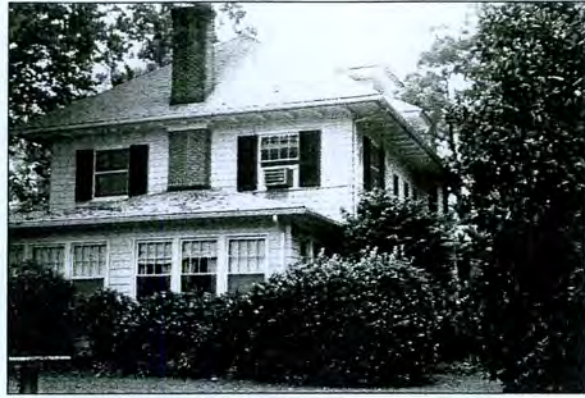
Figure 5-34: Chenar Farm (T-385) Main House, North Façade (right)

The north façade is clad with wood shingles (Figure 5-34). The windows are eight-over-one wood sashes. The windows on the wing are grouped in threes. There are no doors on this façade.

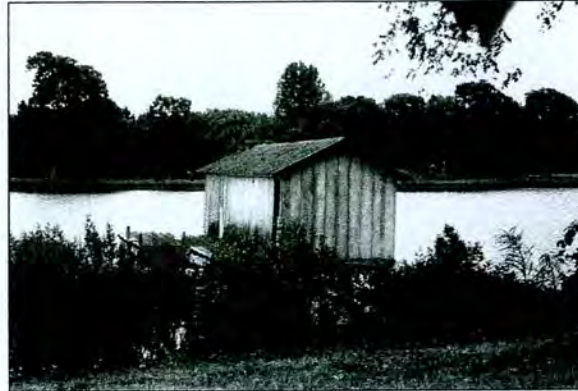
Figure 5-35: Chenar Farm (T-385) Boathouse

The boathouse is located at the end of a wood dock and is a one-story wood frame structure with an undivided interior space (Figure 5-35). The building rests on wood piers. The walls are clad with six inch vertical wood planks. The side gable roof is clad with standing-seam metal. The building is accessed through a hinged wood plank door on the north façade. There are no windows. The interior of the building is unfinished with a wood plank floor.

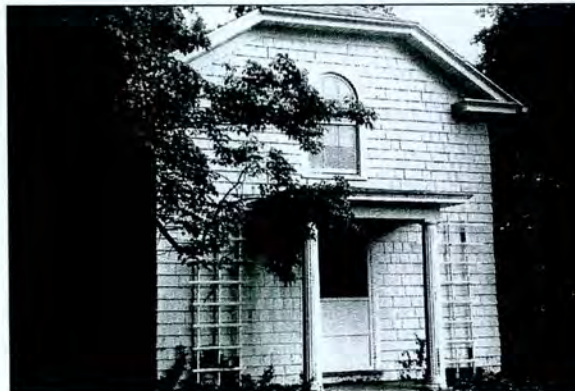
Figure 5-36: Chenar Farm (T-385) Powerhouse

The powerhouse is a two-story wood frame structure with a double pen plan (Figure 5-36). The building rests on a continuous brick foundation. The walls are clad with wood shingles. The clipped gable roof with is clad with asphalt shingles. The front and side entries have hinged two panel one-light wood doors on the north and west façades. The basement entry has a pair of hinged wood plank cellar doors. The windows are six-over-six wood sashes, with an arched six-over-six wood sash on the gable ends. The interior walls and ceiling are clad with beadboard.

The interior has a wood plank floor and open wood stair to the second level. A wood frame greenhouse was originally attached to the rear of the building, but was removed due to deterioration ca. 1980.

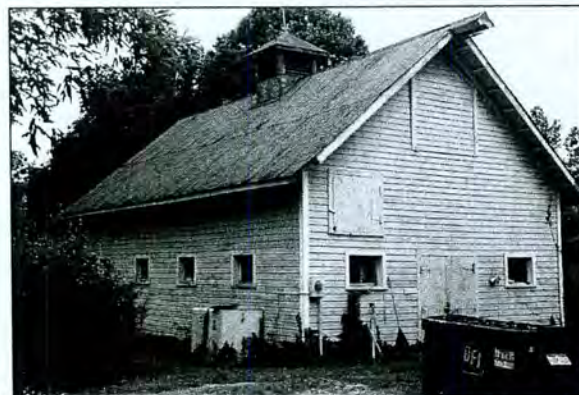
Figure 5-37: Chenar Farm (T-385) Dairy Barn

The dairy barn, constructed ca. 1922, is three bays deep and is of timber frame construction with a one-story milk house rear addition (Figure 5-37). The structure rests on a continuous poured concrete foundation. The walls are clad with beveled wood siding. The front-gable roof is clad with corrugated metal and has a cupola. The doors are hinged wood planks with diagonal bracing. The windows are two-pane steel hopper sashes. The interior of the building is unfinished with a poured concrete floor. Original plans of the barn in the possession of the current owner indicate that the barn was designed by the Extension Service, University of Maryland, Division of Agricultural Engineering, and that the design was either a free or low cost plan.

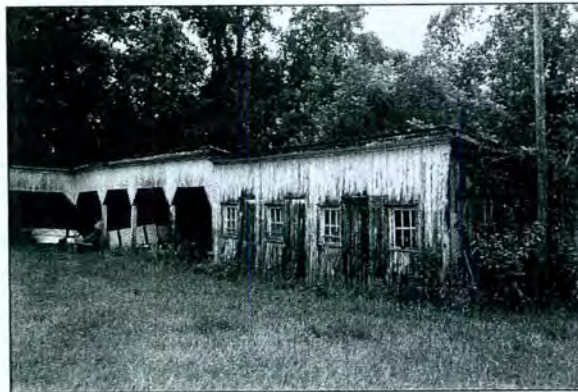
Figure 5-38: Chenar Farm (T-385) Animal Pen and Stable

The ten-bay animal shed and stable are connected structures that form an "L" shape (Figure 5-38). The stables are located on the eastern end. A portion of the southern end of the animal shed was enclosed in the 1960s and converted into a hen house. The animal shed rests on a poured concrete pier foundation. The walls are clad with six inch vertical wood plank siding. The shed roof is clad with standing-seam metal. The doors are hinged wood planks with diagonal bracing. The windows are four-pane wood fixed sashes. The interior of the building is unfinished with an earthen floor. The stable portion rests on a poured concrete pier foundation. The walls are clad with six inch vertical wood plank siding. The shed roof is clad with standing-seam metal. The Dutch doors are hinged wood planks with diagonal bracing. The windows are six-pane wood awning sashes. The interior of the building is unfinished with an earthen floor.

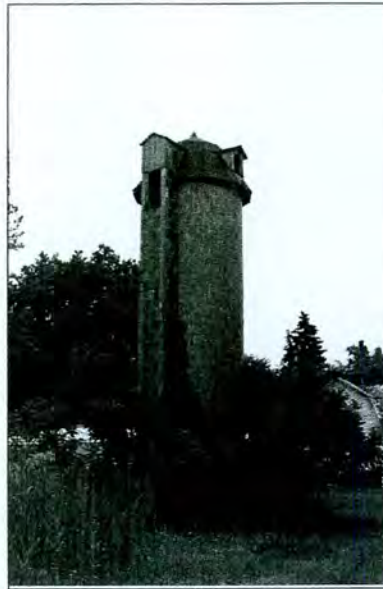
Figure 5-39: Chenar Farm (T-385) Silo

The silo, constructed ca. 1920, is of glazed hollow-tile construction and rests on a poured concrete pad (Figure 5-39). The silo has a hipped roof clad with standing-seam metal. An enclosed metal ladder is located on the north façade.

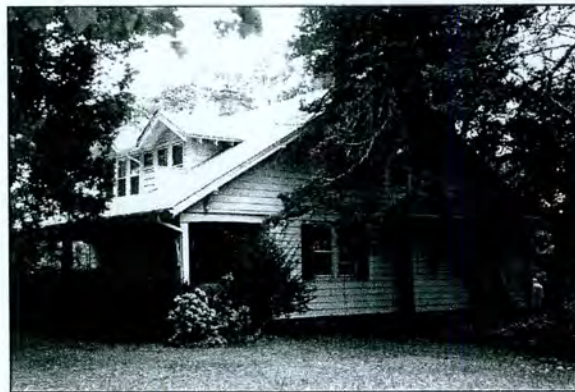
Figure 5-40: Chenar Farm (T-385) Tenant House #1

Tenant house #1, constructed ca. 1910, is a one-and-a-half story wood frame structure with a hall-parlor plan (Figure 5-40). According to a past caretaker, the building was the original main house for the property and was moved to this location ca. 1922 to make room for the construction of the current main residence. The building rests on a continuous concrete masonry unit foundation. The building is clad with aluminum siding. The side gable roof is clad with asphalt shingles and has a paired gable roof dormer on the front façade. The central entry door is flanked by paired nine-over-one wood sashes. The windows are a combination of nine-over-one, eight-over-one, and six-over-one wood sashes. A curved bay window is located on the west façade. The building has two interior brick masonry chimneys. The integral front porch has four square wood columns and a wood plank floor. The rear porch has been enclosed with screening. The interior was not accessible at the time of the survey.

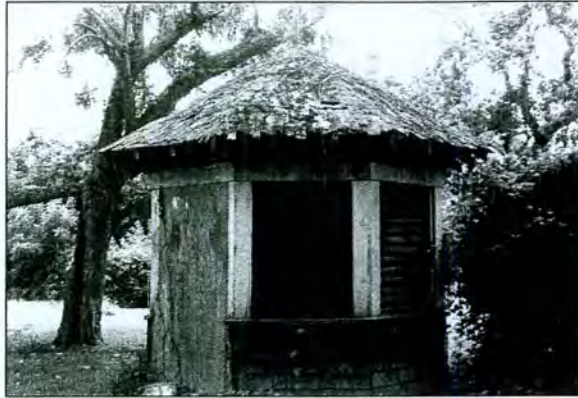
Figure 5-41: Chenar Farm (T-385) Gas House

A one-story octagonal wood frame gas house, constructed ca. 1922, with an undivided interior plan is located to the rear of tenant house #1 (Figure 5-41). The building encloses a brick lined pit. The exterior walls and conical roof are clad with wood shingles. The upper portions of the walls are louvered wood panels. The door is a hinged plywood panel.

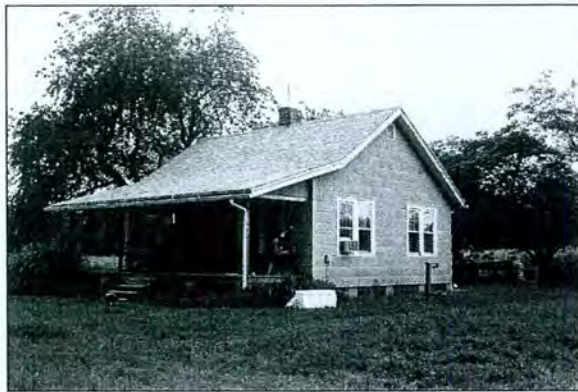
Figure 5-42: Chenar Farm (T-385) Tenant House #2

Tenant house #2, constructed ca. 1930, is a one-story wood frame structure with a hall-parlor plan (Figure 5-42). The building rests on a poured concrete pier foundation with plywood panels infilling the space between piers. The building is clad with asbestos shingles, embossed with a wood texture. The broken side gable roof is clad with asphalt shingles. The hinged two panel four-pane wood entry door is offset. The windows are paired six-over-one wood sashes. The building has a central brick masonry chimney. The integral front porch has four square wood columns and a wood plank floor. The interior was not accessible at the time of the survey.

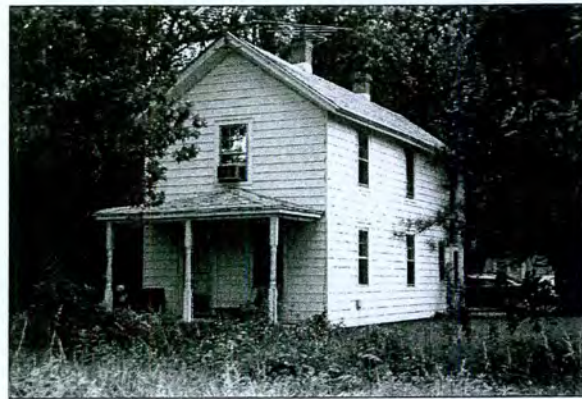
Figure 5-43: Chenar Farm (T-385) Tenant House #3

Tenant house #3, constructed ca. 1890, is a two-story wood frame structure with a three room shotgun plan (Figure 5-43). The building rests on a continuous brick masonry foundation. The building is clad with aluminum siding. The front-gable roof is clad with asphalt shingles. The hinged four panel wood entry door is offset. The windows are six-over-six wood sashes. The building has two central brick masonry chimneys. The front porch has a wood plank floor, three turned wood columns and hipped roof clad with asphalt shingles. The interior was not accessible at the time of the survey.

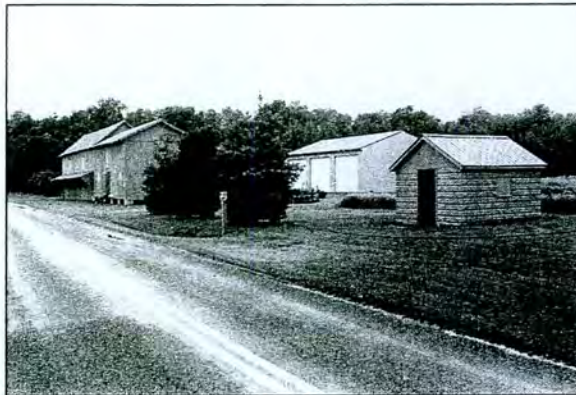
Figure 5-45: Cottingham Farm Orchard Buildings (T-386) Complex

The orchard complex associated within the historic boundaries of the Cottingham Farm and “New House” properties. The tract is located on 341.80 acres of land to the west of the community of Easton in Talbot County, Maryland. The parcel is located on Goldborough Neck Road and contains four structures. The structures include a picker’s shed, a storage building, and two sheds.

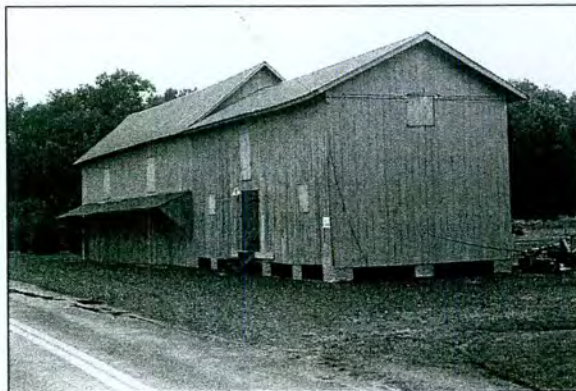
Figure 5-47: Cottingham Farm Orchard Buildings (T-386) Picker's Shed (left) and Storage Building (right)

The main building of the complex is the picker's shed, built ca. 1935 (Figure 5-47). The shed is a two-story timber frame structure with a poured concrete pier foundation. The building is six bays deep with a hayloft on the second level. The side gable roof is clad with corrugated standing-seam metal and has hay hoods on either end.

The one-and-a-half story storage building is connected to the picker's shed on the east façade (Figure 5-47). The storage building rests on a brick pier foundation. The building is clad with vertical wood boards. The side gable roof is clad with corrugated standing-seam metal. The interior is accessed via a hinged wood plank door located three-feet above ground level on the south façade. The loading dock has been removed from the south façade, but its outline remains.

The interiors of both the picker's shed and the storage building were not accessible at the time of the survey.

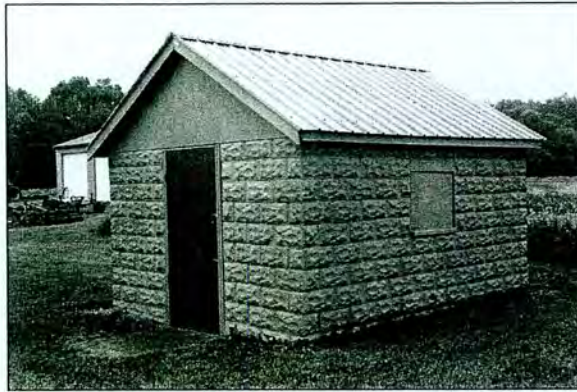
Figure 5-48: Cottingham Farm Orchard Buildings (T-386) Masonry Shed

The shed, constructed ca. 1935, is a one-story masonry structure. The building rests on a poured concrete slab and is constructed of rusticated, rock-faced concrete masonry units. Plywood sheathing is used to infill the gable ends. The front-gable roof is clad with corrugated standing-seam metal. The building is entered through a hinged wood plank door on the south façade. One rectangular window opening, since boarded up, is located on each remaining façade. A poured concrete slab approximately three-feet by three-feet is located outside the entry door. The interior was not accessible at the time of the survey.

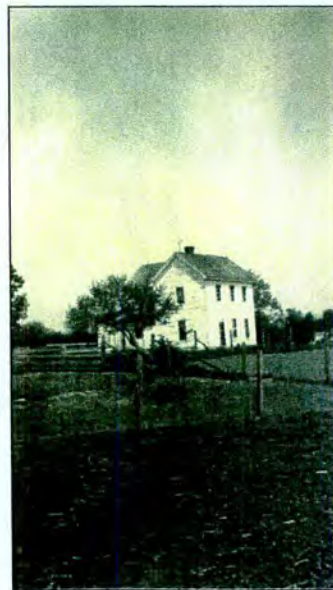
Figure 5-52: Country Rectory (T-387) Prior to Renovations
Image from the Private Collection of Leslie H. Passano

The residence is a two-and-a-half story simple wood frame building, constructed ca. 1890, which originally had a hall-parlor plan (Figure 5-52). The building was significantly altered and turned into a large Colonial Revival residence ca. 1949 when two one-and-a-half story additions were constructed. The existing stylistic elements, including the telescoping additions, Tidewater Maryland interior gable wall chimney, and the stepped exterior brick masonry chimney, all date to the ca. 1949 renovations (Figures 5-53). The building rests on a continuous poured concrete foundation and has a central passage, single-pile plan with a rear ell. The cross-gable roof is clad with wood shingles and has a total of six gable roof dormers on the ca. 1949 additions. The building has an exterior gable wall brick masonry chimney, an interior gable wall brick masonry chimney, and an interior brick masonry chimney.

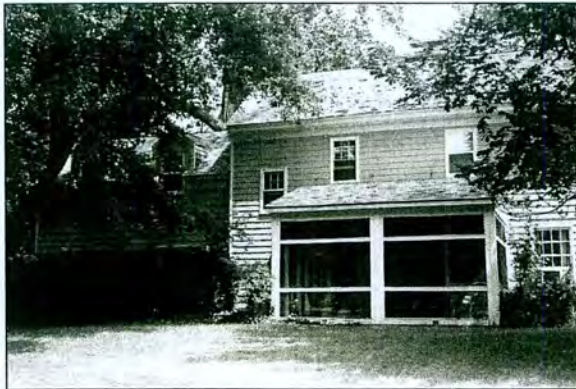
Figure 5-54: Country Rectory (T-387) Main Residence, Southwest Façade (left)

The southwest façade was originally the principle building entry (Figure 5-54). The walls of the original building are clad with wood shingles. Horizontal wood siding is used on the 1949 additions. The building is entered through a hinged twelve-light, wood French door into the original building. The windows on the first floor are eight-over-eight wood sashes with six-over-six wood sashes used on the second level and in the dormers. The front entry porch on the side addition has a wood plank floor, three chamfered wood posts, and a shed roof clad with wood shingles. It has been enclosed with screening.

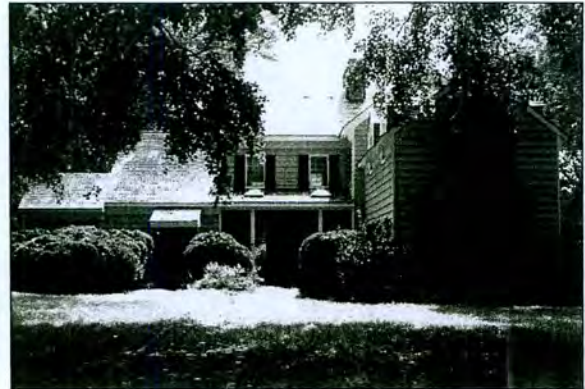
Figure 5-55: Country Rectory (T-387) Main Residence, Northwest Façade (right)

The northwest façade is currently the principle building entry (Figure 5-55). The walls of the original building are clad with wood shingles. Horizontal wood siding is used on the 1949 additions. The building is entered through a hinged wood plank door into the rear addition. A pent roof clad with wood shingles shelters the door. The windows on the first floor are eight-over-eight wood sashes with six-over-six wood sashes used on the second level. The windows have wood shutters. The integral side porch has a wood plank floor and two square wood posts. Two modern skylights have been inserted into the porch roof.

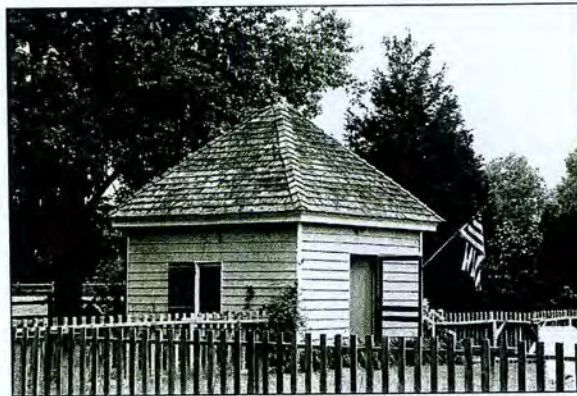
Figure 5-56: Country Rectory (T-387) ca. 1935 Milk House

The milk house, constructed ca. 1935, is a one-story wood frame structure with an undivided interior space. The building rests on a poured concrete slab. The walls are clad with horizontal wood siding. The pyramidal roof is clad with wood shingles. The building is accessed through a hinged wood plank door on the southeast façade. There are no windows, but there are window openings on the remaining three façades which have been enclosed with screening. The interior of the building is finished with a poured concrete floor and plaster walls and ceiling.

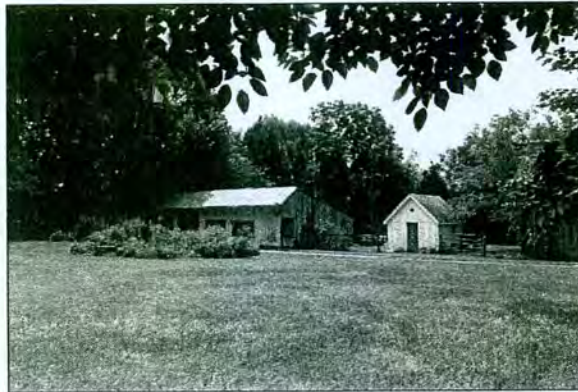
Figure 5-57: Country Rectory (T-387) Carriage House (left) and ca. 1950 Milk House (right)

The carriage house is a one-story timber frame structure, constructed ca. 1950, with an undivided interior space and a side shed addition. The building rests on a continuous concrete masonry unit foundation with poured concrete piers. The addition has a continuous brick foundation. The walls are clad with board and batten siding with vertical wood planks used on the shed addition. The offset side gable roof is clad with standing-seam metal. The building is accessed through three solid wood plank garage doors. The windows are paired six-pane wood hopper sashes. The interior of the building is unfinished with a poured concrete floor. The addition is unfinished with a wood plank floor.

The second milk house, constructed ca. 1950, is a one-story masonry structure with an undivided interior space. The building rests on a poured concrete slab. The walls are constructed of concrete masonry units with three-inch vertical wood boards in the gable ends. The front-gable roof is clad with asphalt shingles. The building is accessed through a hinged wood plank door on the northeast façade. The windows are six-pane wood hopper sashes. The interior of the building is finished with a poured concrete floor, beadboard walls, and a beadboard ceiling.

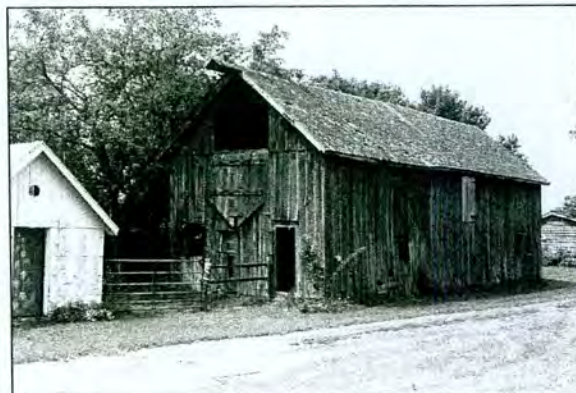
Figure 5-58: Country Rectory (T-387) Barn

The multi-purpose barn, constructed ca. 1930, is four bays deep with a hayloft. The structure rests on a continuous brick masonry foundation. The timber frame barn is clad with board and batten siding. The front-gable roof is clad with wood shingles. The barn has a hay hood on the southeast gable end. The doors are hinged wood planks with diagonal bracing. The windows openings had six-pane wood hopper sashes, many of which are missing. The interior of the building is unfinished with a poured concrete floor.

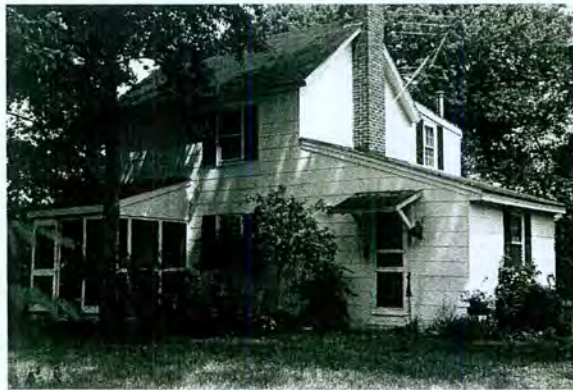
Figure 5-59: Country Rectory (T-387) Tenant House

The tenant house, constructed ca. 1920, is two-story wood frame structure with a single-pen plan and a side and rear addition. The foundation was not visible. The building is clad with asbestos shingles. The cross-gable roof is clad with asphalt shingles. The building is entered through an offset hinged wood four panel entry door. The windows are six-over-six wood sashes. The building has an exterior end gable brick masonry chimney. The front porch shed roof porch has been enclosed with screening. The interior was not accessible at the time of the survey.

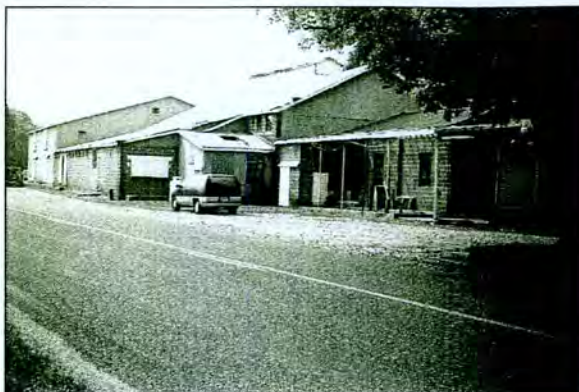
Figure 5-61: Defender Cannery (T-388) Complex

The Defender Cannery, also historically known as Landing Neck Cannery, is located on 4.19 acres of land south of the community of Easton in Talbot County, Maryland. The parcel is located on Landing Neck Road at its intersection with Lloyds Landing Road. The property contains eight structures. The structures include a cannery, two warehouses, an overseers' house, migrant worker's housing, and an office.

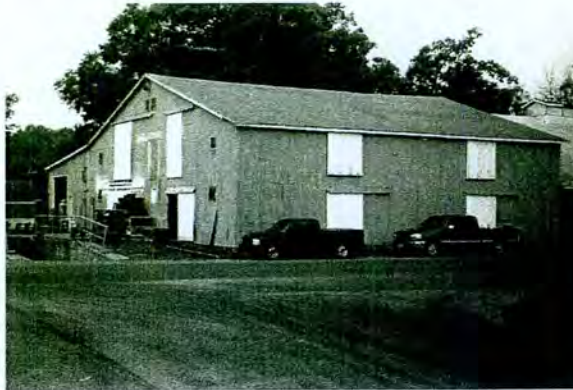
Figure 5-64: Defender Cannery (T-388) Cannery Building, Part 1

Part 1 of the cannery is a two-story timber frame structure with a poured concrete slab foundation (Figure 5-64). The first floor space was most recently used for holding baskets of tomatoes prior to beginning the canning process. The second floor was used for storing the canned goods. Part 1 is six bays deep and has an undivided interior space. The building is clad with corrugated metal. The front-gable roof is clad with corrugated metal. This section of the building is entered through four sets of sliding wood plank doors with diagonal bracing on the first level. Four sets of sliding wood plank doors with diagonal bracing are located on the second level to allow for access to the second floor storage space. The window openings have six-pane wood hopper sashes, which have been boarded up. The interior of the building is unfinished with a poured concrete floor on the first floor. The second floor is accessed via an open string wood stair. Trap doors are located at various points in the wooden second floor to allow for the movement of goods using chutes, which have since been removed.

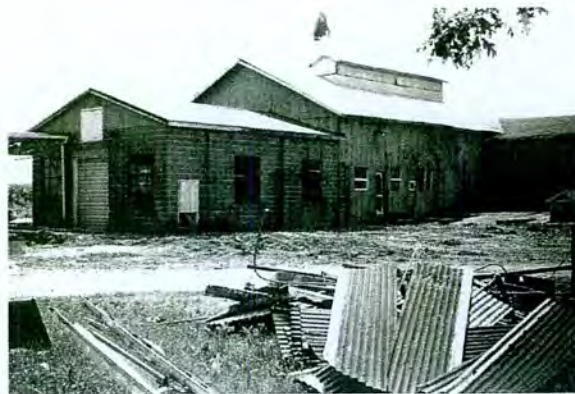
Figure 5-65: Defender Cannery (T-388) Cannery Building, Parts 3, 4, 5, and 6

Part 3 of the cannery is a one-story masonry structure with a poured concrete slab foundation (Figure 5-65). The space was most recently used for storing the canned goods as they were cooling from the pasteurization process. Part 3 is three bays deep and has an undivided interior space. The walls are constructed of concrete masonry units. The gable roof is clad with corrugated metal. This section of the building has no exterior doors. The windows are two-pane metal hopper sashes which have been boarded up. The interior of the building is unfinished with a poured concrete floor.

Part 4 of the cannery is a one-and-a-half story masonry structure with a poured concrete slab foundation (Figure 5-65). The space was most recently used for canning the processed goods. Part 4 is three bays deep and has an undivided interior space. A lab is located in the east corner of the space with a kitchen space to the rear. The walls are constructed of concrete masonry units and are clad with vertical boards on the northwest and southwest façades. The gable roof is clad with corrugated metal and has a boarded up skylight with a side gable roof located along the ridgeline. The roof covers both Part 4 and Part 2. This section of the building is entered through a hinged wood plank door into the kitchen. A set of sliding wood plank doors with diagonal bracing allow for access from the second floor storage space to Part 3. The windows are two-pane metal hopper sashes. The kitchen has a large rectangular opening for food distribution which has since been boarded up. The interior of the building is unfinished with a poured concrete floor. Drainage channels have been cut into the floor to accommodate the waste water. The trench was connected to the pond via metal pipes. The second floor is accessed via the stair in Part 1. Trap doors are located at various points in the wooden second floor to allow for the movement of goods using chutes, which have since been removed.

Part 5 of the cannery is a one-story masonry structure with a poured concrete slab foundation (Figure 5-65). The space was most recently used as a loading area. Part 5 is one bay deep and has an undivided interior space. The walls are constructed of concrete masonry units. The gable roof is clad with corrugated metal. This section of the building has a metal roll-up door. The windows are six-over-six-over-one double hung metal sashes. The interior of the building is unfinished with a poured concrete floor.

Part 6 of the cannery is the ruins of a one-story masonry structure with a poured concrete slab foundation (Figure 5-65). The space was used for the pasteurization process and contained the boilers for the cannery. Part 6 had an undivided interior space. The walls were constructed of

concrete masonry units. The gable roof was clad with corrugated metal. This section of the building is being reconstructed by the current property owners.

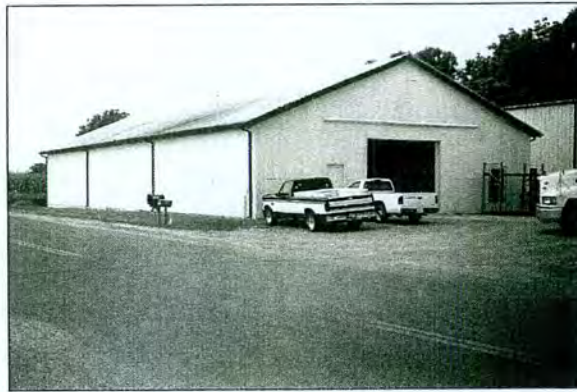
Figure 5-66: Defender Cannery (T-388) Tomato Warehouse

There are two timber frame warehouses, both constructed prior to 1943, located to the northeast of the cannery building. The northernmost warehouse was used for tomato storage (Figure 5-66) while the other warehouse was used for empty can storage. Both warehouses are one-story structures with an undivided interior space. The buildings are six bays deep and rest on a continuous poured concrete foundation. The walls of the tomato warehouse are clad with corrugated metal and the walls of the can warehouse are clad with corrugating standing-seam metal. The front-gable roofs are clad with corrugated metal. The buildings are accessed through roll up metal doors on the northwest façade. There are no windows. The interior of the building is unfinished with a poured concrete floor. Insulation has been installed on all interior walls.

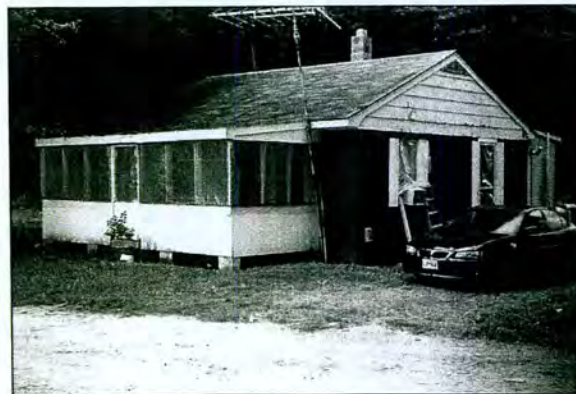
Figure 5-67: Defender Cannery (T-388) Overseers' House

The overseer's house is a one-story wood frame structure, constructed ca. 1940, with a hall-parlor plan and a rear shed roof addition (Figure 5-67). The building rests on a concrete masonry

unit pier foundation with a continuous concrete masonry unit foundation on the rear addition. The building is clad with asbestos shingles and has horizontal wood siding in the gable ends. The rear addition is clad with vertical wood siding. The side gable roof is clad with asphalt shingles. The building is entered through a single-panel three-pane hinged wood entry door into the enclosed porch. The windows are two-over-two horizontal wood sashes. The building has an interior concrete masonry unit chimney. The front porch has been enclosed and has three-pane metal louvered windows. The interior was not accessible at the time of the survey.

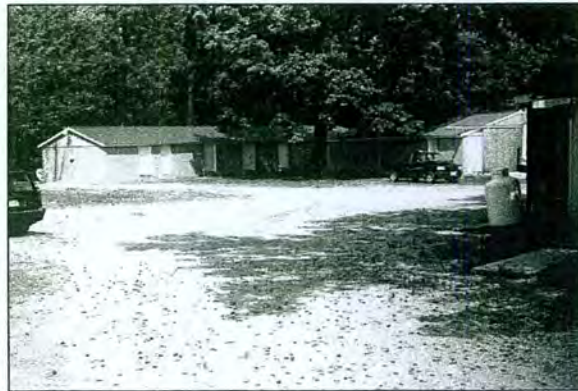
Figure 5-68: Defender Cannery (T-388) Migrant Worker Housing

There are two blocks of migrant worker's housing, one housing ten single-pen units and one housing fourteen single-pen units (Figure 5-68). Each block, constructed ca. 1940, is a one-story masonry structure with a poured concrete slab foundation. Oyster shells have appeared in part of the foundation during recent renovations. The walls are constructed of concrete masonry units with vertical wood siding in the gable ends. The side gable roof is clad with standing-seam metal. Each unit is entered through a modern hinged steel core door. The windows were two-over-two wood sashes, which have since been boarded up. Each unit is approximately twelve feet by twelve feet and is unfinished with a poured concrete floor.

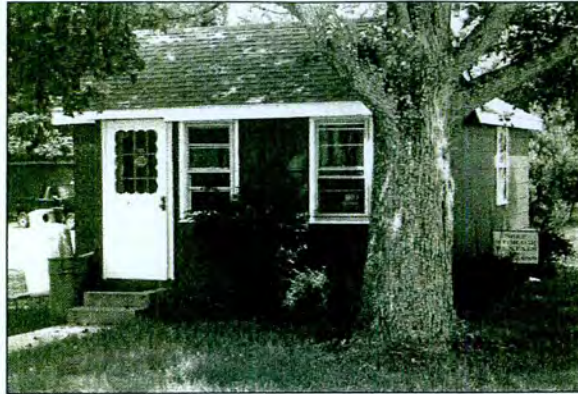
Figure 5-69: Defender Cannery (T-388) Office

The office is a one-story wood frame structure, constructed ca. 1940, with a hall-parlor plan and a rear shed roof addition (Figure 5-69). The building rests on a concrete masonry unit pier foundation. The building is clad with asbestos shingles. The cross-gable roof is clad with asphalt shingles. The building is entered through a hinged single-panel, single-pane, cross braced wood entry door. The windows are two-over-two horizontal wood sashes. The building has an exterior end gable concrete masonry unit chimney. The interior was not accessible at the time of the survey.

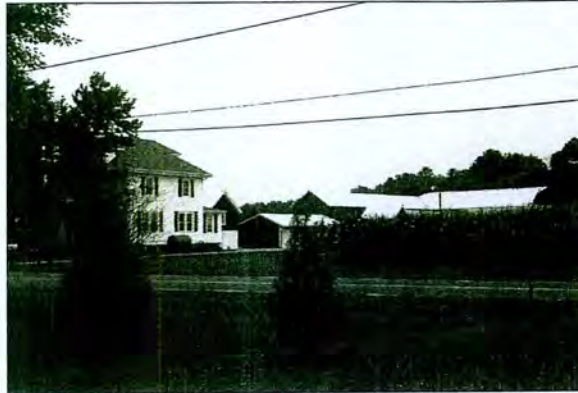
Figure 5-72: Mullikin Farm (T-389) Complex

The Mullikin Farm is located on 19.12 acres of land just to the north of the community of Trappe in Talbot County, Maryland and contains twelve structures. The structures include a residence, play house, carriage house, pump house, granary, three machine sheds, barn, corncrib, hen house, and what appears to be a seed house.

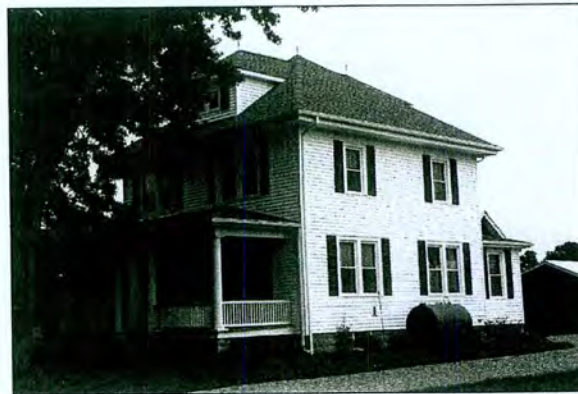
Figure 5-74: Mullikin Farm (T-389) Residence

The residence is a two-and-a-half story wood frame foursquare house, constructed ca. 1910 (Figure 5-74). The building rests on a continuous rusticated rock-faced concrete masonry unit foundation. The pyramidal roof is clad with asphalt shingles and has two dormers. The hipped roof dormers are located on the west and east façades and have paired three-pane wood hopper sashes. The building has an interior brick masonry chimney.

front door with a three-light transom and one-light sidelights. The windows are paired three-over-one wood sashes. The basement has three-pane wood hopper sashes. The front entry porch has a wood plank floor on a rusticated rock-faced concrete masonry unit pier foundation, four wood Doric columns, and a hipped roof clad with asphalt shingles.

The south façade is clad with horizontal vinyl siding above the basement level. The windows are paired three-over-one wood sashes on the first floor and single three-over-one wood sashes on the second level. The basement has three-pane wood hopper sashes. There are no doors on this façade.

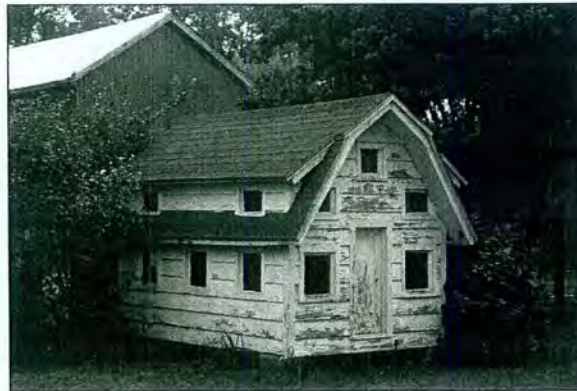
Figure 5-75: Mullikin Farm (T-389) Play House

The play house, constructed ca. 1940, is a one-story wood frame structure with an undivided interior space (Figure 5-75). The building rests on a rusticated rock-faced concrete masonry unit pier foundation. The walls are clad with horizontal wood siding. The gambrel roof is clad with asphalt shingles. The building is entered through a small hinged wood plank door. The square window openings have had Plexiglas inserted. The interior of the building is finished with a linoleum floor and wallpaper.

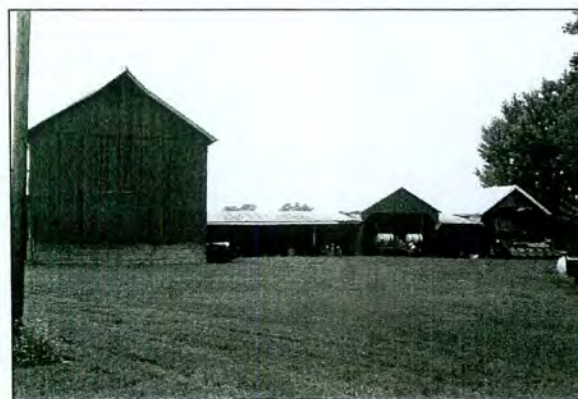
Figure 5-80: Mullikin Farm (T-389) Machine Sheds

A row of four timber frame machinery sheds is located on the east façade of the barn (Figure 5-80). The sheds are four bays, one bay, one bay, and one bay in size. The sheds rest on a combination pier and continuous rusticated rock-faced concrete masonry unit foundation. The walls are clad with corrugated standing-seam metal. The side and front-gable roofs are clad with corrugated standing-seam metal. The buildings are open on the south façade. There are no doors or windows. The interior of the building is unfinished with an earthen floor.

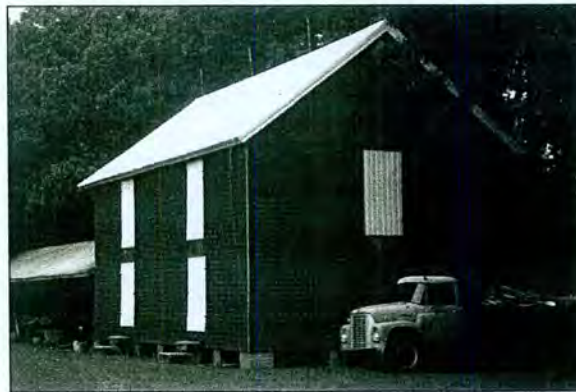
Figure 5-81: Mullikin Farm (T-389) Potential Seed House (right) and Machinery Shed (left)

The building that appears to be a seed house is a two-story structure with an undivided interior space (Figure 5-81). The building is four bays deep and rests on a concrete masonry unit pier foundation. The walls are clad with asphalt shingles over wood boards. The side gable roof is clad with corrugated standing-seam metal and has four lightning rods located along the roof ridge. The building is accessed through hinged wood plank doors on the west façade. Hinged wood plank doors are also located on the second level. There are no window openings. The interior of the building is unfinished with a wood plank floor. A wood open string stair leads to the second floor.

A six bay timber frame machine shed is attached to the north façade of the seed house (Figure 5-81). The shed rests on a combination pier and continuous poured concrete foundation. The walls are clad with six-inch horizontal wood planks. The side gable roof is clad with corrugated metal.

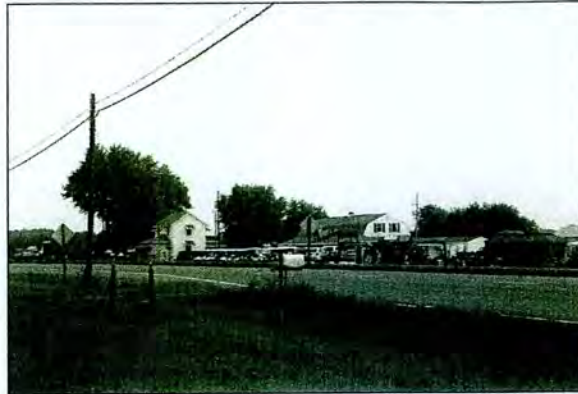
Figure 5-83: Mullikin Tenant Farm (T-390) Complex

The Mullikin Tenant Farm is located on 29.26 acres of land just inside the northern boundary of the community of Trappe in Talbot County, Maryland and contains seven historic structures. The structures include a barn, shed, privy, silo, milk house, tenant house, and dairy manager's house. A number of other structures are located on the property, including a gambrel roof barn constructed ca. 1970, which are associated with the property's current commercial use.

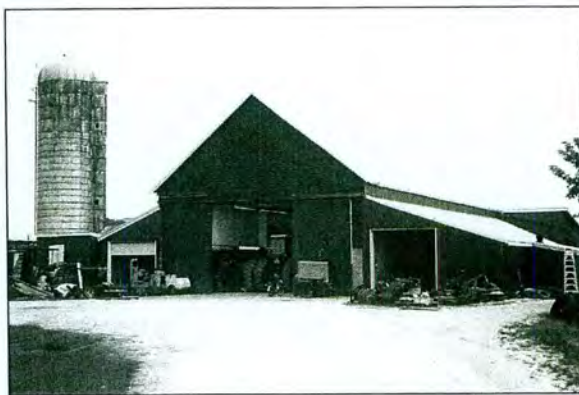
Figure 5-85: Mullikin Tenant Farm (T-390) Barn and Silo (left)

The barn has been extensively altered. The original building had a center aisle plan with five side and rear additions (Figures 5-85 & 5-86). The central and oldest portion of the building had the roof raised within the last five years in order to accommodate machinery. The structure rests on a concrete masonry unit foundation with poured concrete piers. The walls are clad with standing-seam metal with asphalt shingles located in the gable ends. The various gable and shed roofs are clad with corrugated standing-seam metal. The roof of the rear front-gable addition is supported

The silo, constructed ca. 1940, is of concrete stave construction and rests on a poured concrete pad (Figure 5-85). The silo has a hemispherical roof clad with standing-seam metal. A metal ladder is located on the north façade.
