TALBOT COUNTY, MARYLAND 20TH CENTURY AGRICULTURAL CONTEXT AND HISTORIC RESOURCE SURVEY

Talbot County Historic Preservation Commission
Court House
11 North Washington Street
Easton, Maryland 21601
(410) 770-8030
2003

Mark R. Edwards, Project Manager
Fred Holycross, Architectural Historian
Amy Barnes, Architectural Historian

A county-wide thematic context for agricultural buildings and structures dating from 1900 to 1955 and a survey of fifteen (15) related historic resources was conducted by URS Corporation (URS) on behalf of the Talbot County Historic Preservation Commission and the Talbot County Council in 2003. The purpose of this project was to correct one of the deficiencies in the existing survey data for Talbot County that was noted by Paul Baker Touart in his 1992 thematic context study for the county using Certified Local Government (CLG) funds, passed through the Maryland Historical Trust (MHT).

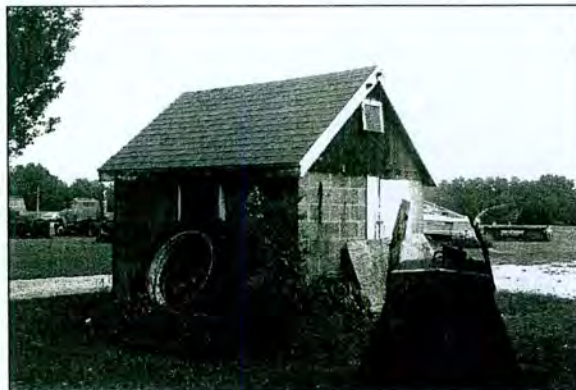
Figure 5-87: Mullikin Tenant Farm (T-390) Milk House

The ca. 1935 milk house is a one-story masonry structure with an undivided interior space (Figure 5-87). The building rests on a poured concrete slab. The walls are constructed of concrete masonry units. The front-gable roof is clad with asphalt shingles. The building is accessed through a hinged wood plank door on the south façade. The windows are six-pane wood hopper sashes. The interior of the building is finished with a poured concrete floor, beadboard walls, and a beadboard ceiling.

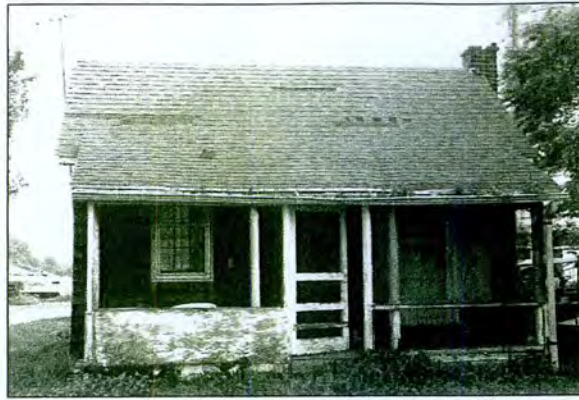
Figure 5-88: Mullikin Tenant Farm (T-390) Tenant House

The tenant house, constructed ca. 1920, is a one-story wood frame structure with a single-pen plan (Figure 5-88). The building rests on a concrete masonry unit pier foundation which has been covered with pressed metal sheets designed to imitate rusticated concrete masonry units. The building is clad with wood shingles. The side gable roof is clad with asphalt shingles. The building is entered through an offset hinged wood three panel four light entry door. The windows are six-over-six wood sashes, each of which has a pent roof. The building has an exterior brick end gable masonry chimney. The front porch has been enclosed with screening. The interior was not accessible at the time of the survey.

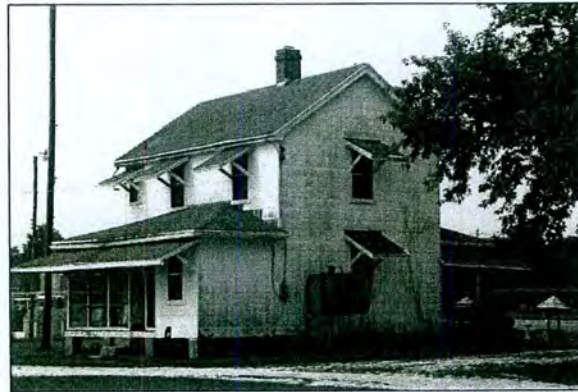
Figure 5-89: Mullikin Tenant Farm (T-390) Dairy Manager's House

The Dairy Manager's house, constructed ca. 1920, is a two-story wood frame structure with a hall-parlor plan (Figure 5-89). The building rests on a continuous concrete masonry unit foundation. The building is clad with asbestos shingles. The side gable roof is clad with asphalt shingles. The building is entered through a single-panel and eight-light French door into an entry vestibule. The rear entry door is a wood three panel four light entry door. The windows are six-over-six wood sashes, each of which has a pent roof. The building has a central brick masonry chimney. The front porch has been enclosed with screening. The interior was not accessible at the time of the survey.

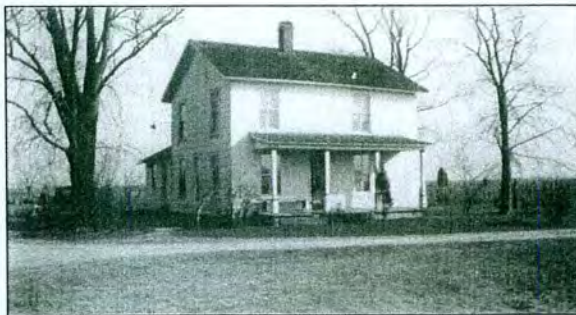
Figure 5-93: Lindemann Fam (T-391) Residence ca. 1937 (left)

The residence is a two-story wood frame building, constructed ca. 1890, with significant twentieth-century alterations including side and rear additions (Figures 5-93 & 5-94). The building rests on a continuous brick masonry foundation and has a hall-parlor plan. The cross-gable roof is clad with asphalt shingles. The building has an exterior gable wall brick masonry chimney and an exterior side wall brick masonry chimney.

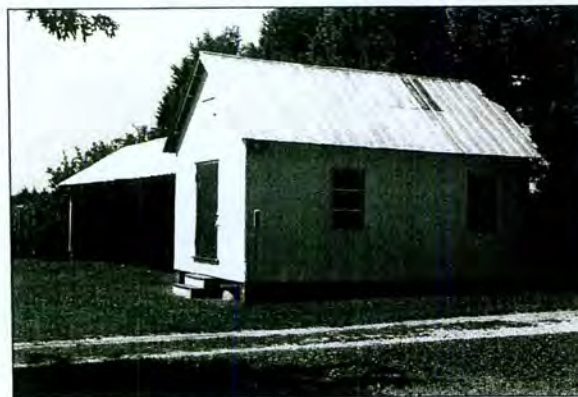
Figure 5-95: Lindemann Farm (T-391) Granary

Adjacent to the implement shed is the granary which is a one-story timber frame structure with an undivided interior space (Figure 5-95). The building rests on a concrete masonry unit pier foundation. The walls are clad with six inch vertical wood planks. The front-gable roof is clad with standing-seam metal. The building is accessed through a hinged plywood panel door on the east façade. There are four three-pane vinyl double sash windows, which were added at a later date. The interior of the building is unfinished with a wood plank floor.

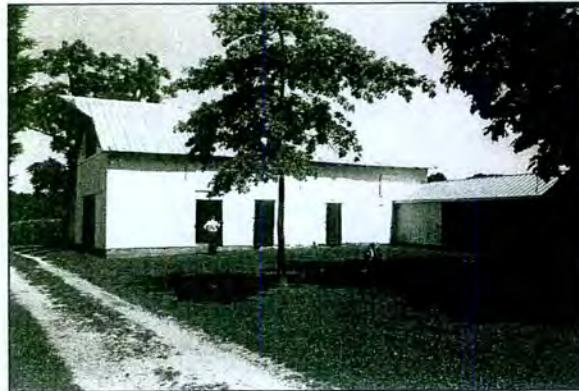
Figure 5-96: Lindemann Farm (T-391) Barn

The multi-purpose barn, constructed prior to 1937, is three bays deep with a hayloft and a ca. 1945 addition built to accommodate a hay fork (Figure 5-96). The structure rests on a brick masonry pier foundation. The timber frame has pegged mortise and tendon joints and was originally clad with board and batten. The building is currently clad with six-inch vertical wood planks. The front-gable roof is clad with standing-seam metal over corrugated metal and, on the oldest portion, wood shingles. The barn has a hay hood on the south gable end. The Dutch doors are hinged wood plank with diagonal bracing. Sliding wood plank doors are located on the gable ends. The windows are two-pane steel hopper sashes. The interior of the building is unfinished with an earthen floor and wood animal pens. There is a two bay shed roof machine shed addition on the west façade.

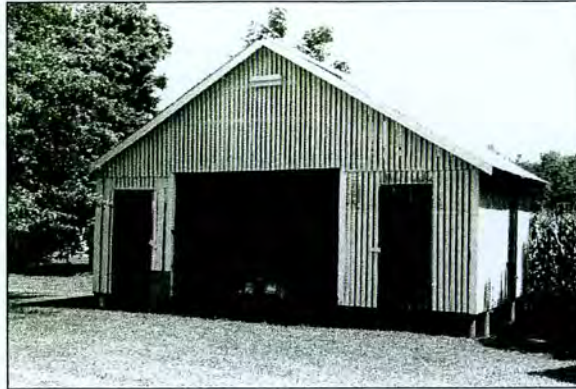
Figure 5-97: Lindemann Farm (T-391) Drive-Thru Corncrib

The drive-thru corncrib is a one-story timber frame structure constructed in two phases (Figure 5-97). The original eight-foot wide corncrib was constructed in 1942 and has a pier foundation constructed of terra cotta soil pipes. The walls are clad with six inch vertical wood boards, spaced approximately one-inch apart. The crib is accessed through a hinged six inches wood plank door with one-half-inch spacing on the south façade. In 1952, a second crib was constructed to the west of the first. The same construction methods and materials were used, with the only difference being that the second crib is six-foot wide and is clad with three inch vertical wood boards, spaced approximately 1-inch apart. In 1952, the front-gable roof clad with standing-seam metal was also added, bridging the two cribs. There are no windows. The interior of the building is unfinished with a wood plank floor.

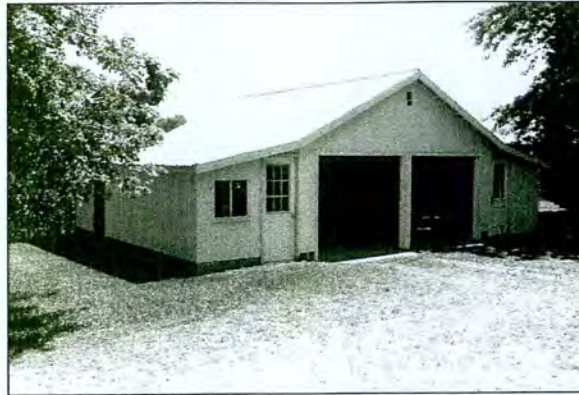
Figure 5-98: Lindemann Farm (T-391) Garage

The garage, constructed ca. 1957, is a one-story light timber frame structure three bays wide with an undivided interior space (Figure 5-98). The side bays are used for storage and as a workshop space. The building rests on a poured concrete slab. The walls are clad with six inch vertical wood boards. The broken front-gable roof is clad with standing-seam metal. The building is accessed through two hinged two panel nine-pane wood doors on the south façade which flank the two large central rectangular openings for the cars. The rear doors are hinged plywood panels. The windows are six-pane and two-pane wood hopper sashes. The interior of the building is unfinished with a poured concrete floor.

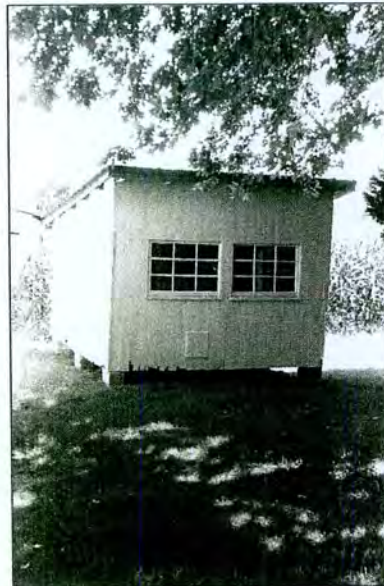
Figure 5-99: Lindemann Farm (T-391) Hen House

Adjacent to the garage is the hen house, constructed prior to 1937, which has been moved to its current location from elsewhere on the property (Figure 5-99). The building is a one-story light timber frame structure with an undivided interior space. The building rests on a concrete masonry unit pier foundation. The walls are clad with six inch vertical wood board. The shed roof is clad with standing-seam metal. The building is accessed through a hinged plywood panel on the north façade. The window openings have been infilled with nine-pane wood hopper sashes. The interior of the building is unfinished with a wood plank floor.

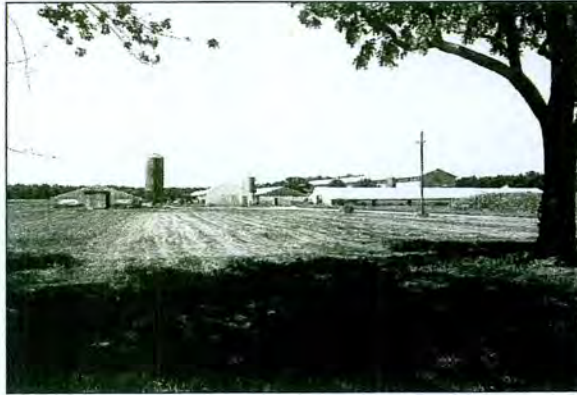
Figure 5-101: Poultry Farm at 30090 Lloyds Landing Road (T-392) Complex

The poultry farm located at 30090 Lloyds Landing Road is located on 2.82 acres of land to the south of the community of Easton in Talbot County, Maryland. The parcel is located on between Landing Neck Road and Schwaninger Road and was historically known as Parcels A and B of the “Jamaica” tract. The property contains fourteen structures. The structures include a residence, three broiler houses, a hatchery, five grain bins, three machinery sheds, and a multi-purpose shed.

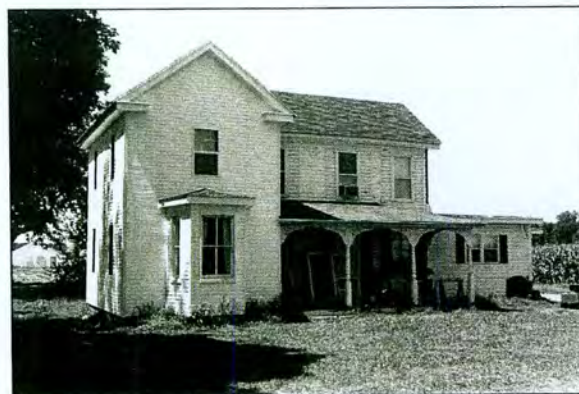
Figure 5-103: Poultry Farm (T-392) Residence

The main house is a two-story wood frame structure, built ca. 1900, with two rear and one side wood frame addition (Figure 5-103). The building rests on a continuous brick masonry foundation and has a front facing "L"-shaped plan. The cross-gable roof is clad with asphalt shingles. There is one interior brick masonry chimney in the rear addition. The property is currently undergoing renovations with the windows and siding being replaced and the wood shutters being removed.

The southeast façade is the principle building entry. The walls are clad with a combination of beveled wood and horizontal vinyl siding. The building is entered through a central hinged four panel wood front door. The door has a three-light transom and two-light sidelights. The seven original windows are two-over-two wood sashes with a six-over-six vinyl sash being used as a replacement unit. A hipped roof bay window with two-over-two and one-over-one sashes is located on the projecting wing. Shutters are located on the windows in the first floor porch area. The front porch has five turned wood columns with scrollwork brackets. The porch has a wood plank floor on a brick pier foundation. The hipped porch roof is clad with asphalt shingles.

The southwest façade is clad with horizontal vinyl siding. The four windows are six-over-six vinyl replacement sashes. There are no doors on this façade and all shutters have been removed.

The northwest façade is where the rear additions attach to the original structure. The walls are clad with a combination of beveled wood and horizontal vinyl siding. The two original windows are two-over-two wood and three-pane wood hopper sashes with a six-over-six vinyl replacement sash. There are no doors on this façade and all shutters have been removed.

The northeast façade is dominated by the low-pitch hip roof side addition. The walls are clad with beveled wood siding. The building is entered through a hinged wood front door with a nine-pane window on the side addition. The two original windows are two-over-two wood sashes with paired one-over-one vinyl sashes in the addition. Shutters are located on the side addition windows; all other shutters have been removed. The side porch has a flat roof and two square wood posts on a poured concrete foundation.

The telescoping rear additions are both of wood frame construction and rest on a continuous brick foundation. The walls are clad with beveled wood siding. The addition is entered through a hinged wood front door with a four-pane window. There are two one-over-one aluminum sashes, three six-over-six vinyl sashes, two one-over-one vinyl sashes, and two nine-pane wood frame hopper sash windows. All shutters have been removed.

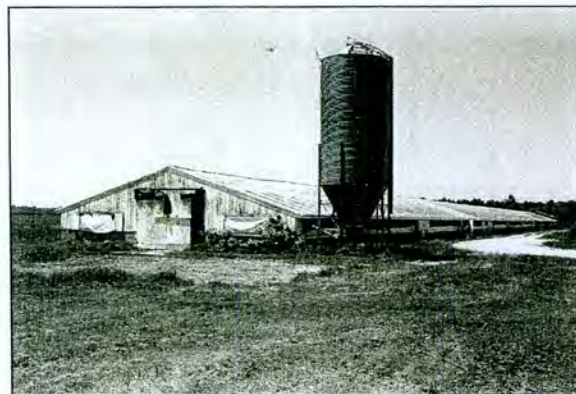
Figure 5-104: Poultry Farm (T-392) Broiler House #1 with Grain Bin

There are three broiler houses, built ca. 1935, located in the agricultural area. Each building is a one-story light timber frame structure with an undivided interior space (Figure 5-104). The

The exterior walls of broiler house #2 are clad with horizontal corrugated metal. The side gable roof is clad with standing-seam metal.

The exterior walls of broiler house #3 are clad with T-111 siding. The side gable roof is clad with asphalt paper. The building collapsed during winter 2002-2003.

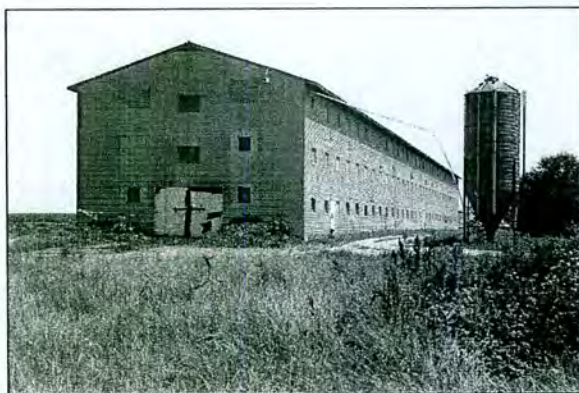
Figure 5-105: Poultry Farm (T-392) Hatchery with Grain Bin

The hatchery, built ca. 1960, is a three-story light timber frame structure with an undivided interior space (Figure 5-105). The building is fifteen bays deep and rests on a poured concrete slab with a one-foot curb around the perimeter. The walls are clad with horizontal corrugated metal and the side gable roof is clad with standing-seam metal. The gable ends have paired hinged wood plank doors. Square openings flank the doorway and a large fan is located in both gable ends. Hinged wood plank doors are located at regular intervals along the west façade with regularly spaced square opening between the doorways. All window opening have been boarded up with rigid sheet insulation. Hooded metal ventilators are located at regularly spaced intervals along the east faced. The interior of all three broiler houses are unfinished with a poured concrete floor. The second and third floors have wood plank floors and are reached via an open string wood staircase.

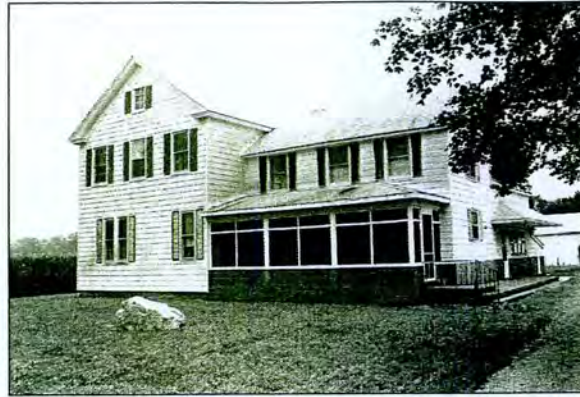
Figure 5-108: Clarke W. Sewell Farm (T-393) Residence

The main house is a two-and-a-half story wood frame structure, built ca. 1900, with a rear and a side wood frame addition (Figure 5-108). The building rests on a brick pier foundation with a continuous brick masonry foundation under the side addition. The rear addition has a continuous poured concrete foundation. The building has a hall-parlor plan. The cross-gable roof is clad with asphalt shingles. There is one interior brick masonry end gable chimney.

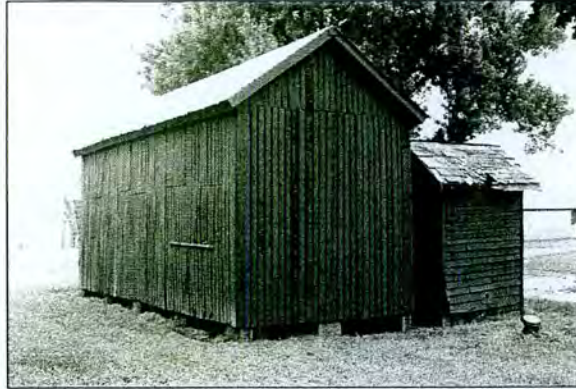
Figure 5-110: Clarke W. Sewell Farm (T-393) Cornerrib

The corner crib is a one-story timber frame structure with an undivided interior space (Figure 5-110). The building rests on a brick pier foundation with a concrete protective coating. The walls are clad with three inch vertical wood planks spaced approximately 1-inch apart. The front-gable roof is clad with corrugated metal. The building is accessed through a hinged plywood panel door on the north façade and hinged wood plank feeder doors at the roofline. There are no windows. The interior of the building is unfinished with a wood plank floor.

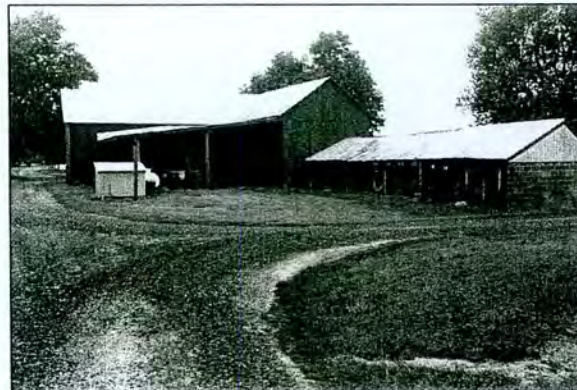
Figure 5-111: Clarke W. Sewell Farm (T-393) Barn with Machine Shed Addition

The multi-purpose barn is three bays deep with a hayloft and a two side additions, one of which is a machine shed (Figure 5-111). The structure rests on a brick masonry pier foundation. The timber frame barn is clad with board and batten siding. The side addition is clad with plywood panels. The cross-gable roof is clad with corrugated metal. The barn has a hay hood on the north and south gable ends. The doors are hinged wood planks with diagonal bracing and are clad with either plywood panels or board and batten siding. One door is a Dutch door. The windows openings have been boarded up. The interior of the building is unfinished with a wood plank floor. The machine shed side addition is constructed of concrete masonry units and has a side

gable roof clad with corrugated metal. The interior of the building is unfinished with an earthen floor.

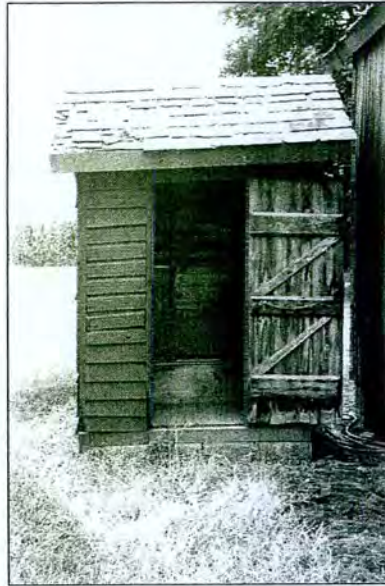
Figure 5-112: Clarke W. Sewell Farm (T-393) Privy

The privy is a one-story wood frame structure with an undivided interior space. The building rests on a concrete masonry unit pier foundation. The walls are clad with three inch vertical wood planks with beveled wood siding used on the north façade. The side gable roof is clad with slate and has metal and asphalt shingle patches. The building is accessed through a hinged wood plank door on the south façade. The windows have been boarded up. The interior of the building is unfinished with a wood plank floor. The ceiling is clad with one-inch wood boards spaced one-half-inch apart. There are three seats with lids and no interior partitions.

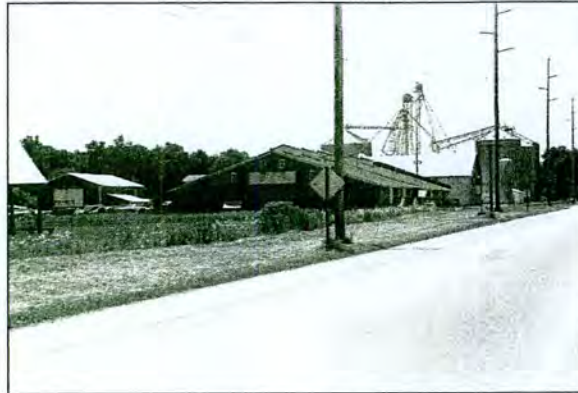
Figure 5-114: Wye Mills Feed Company (T-394) Complex

Wye Mills Feed Company, currently known as Talbot Grain, is located on 9.84 acres of land in the community of Cordova in Talbot County, Maryland and contains twenty-eight structures. The structures include four warehouses, a seed house, storage buildings, an office, a caretaker's cottage, a water tank, seven fertilizer tanks, a scale, and a grain elevator with twelve bins.

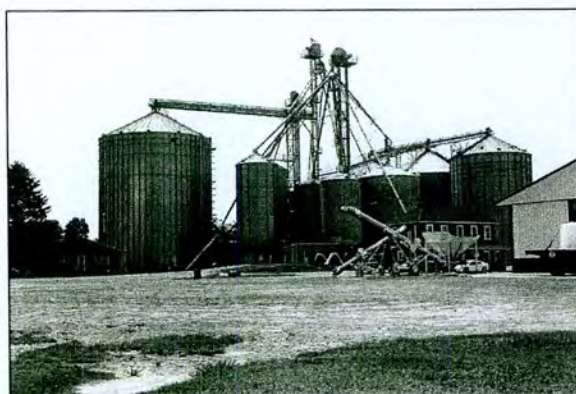
Figure 5-116: Wye Mills Feed Company (T-394) Grain Elevator and Grain Bins

The grain elevator, constructed from ca. 1974 to the present, is a modern steel structure connecting twelve grain bins (Figure 5-116). There are four large and eight medium sized grain bins. All of the grain bins are located on a poured concrete slab and have a steel frame. The bins are clad with corrugated metal and have conical roofs clad with standing-seam metal. The bins are entered through metal hatches. A truck scale with concrete masonry unit walls is located directly in front of the tanks.

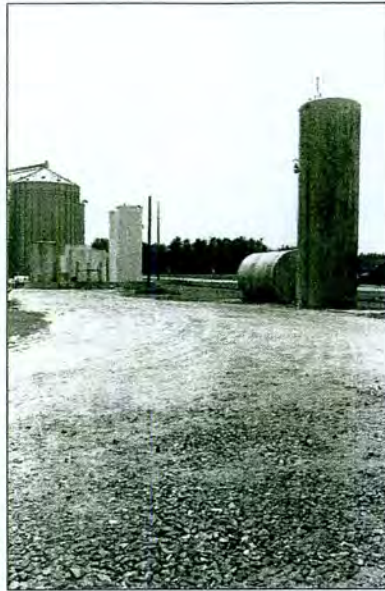
Figure 5-117: Wye Mills Feed Company (T-394) Fertilizer Tanks

There are seven liquid fertilizer tanks, constructed from ca. 1960 to the present (Figure 5-117). Tanks are located on a poured concrete slab and have a steel frame. The bins are clad with riveted steel plates and have domed roofs also clad with steel plates. The bins have metal hatches on the roof to allow for filling and the product is dispensed through valves and pumps located at the base of the tanks. Five of the tanks are located within a 4' poured concrete wall.

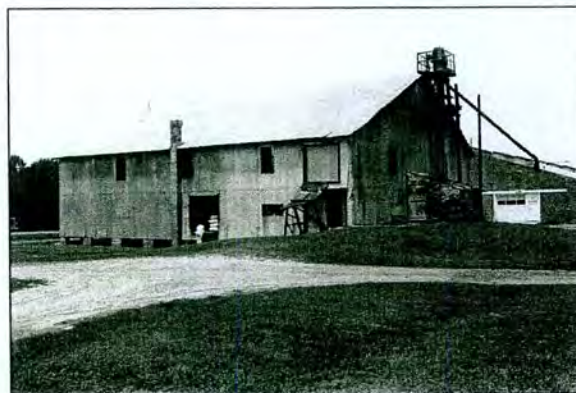
Figure 5-118: Wye Mills Feed Company (T-394) Seed House

The seed house is a two-story timber frame structure with an undivided interior space (Figure 5-118). The building is eight bays deep and rests on a poured concrete pier foundation. The walls are clad with corrugated metal. The front-gable roof is also clad with corrugated metal and has five lightning rods and a weather vane located along the roof ridge. The building is accessed through sliding wood plank doors on all façades. Hinged wood plank doors are located on the second level. The rectangular window openings contain paired twelve-pane wood hopper sashes which have been boarded up. The second floor windows are six-over-six wood sashes. One grain elevator is located on the southeast façade of the building and a second is located in the north corner of the building. An exterior brick masonry chimney is located on the southwest façade.

The interior of the building is unfinished with a wood plank floor. A wood open string stair leads to the second floor.

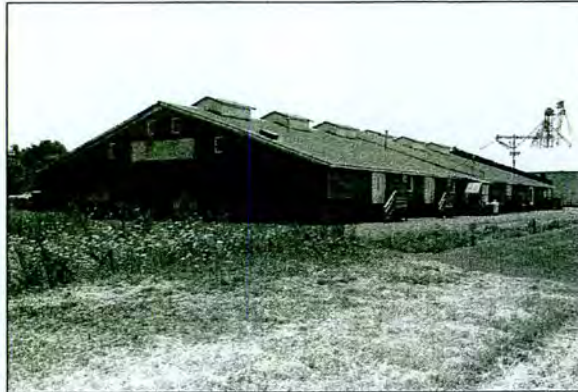
Figure 5-119: Wye Mills Feed Company (T-394) Brick Masonry Warehouse

The brick masonry warehouse, constructed ca. 1920, is a one-story structure with an undivided interior space (Figure 5-119). The building is six bays deep and rests on a continuous brick foundation. The brick is laid using a six course American bond. The gable ends have stepped parapet walls. A stepped concrete masonry unit wall is located in the center of the building and projects up above the roofline. The side gable roof is clad with standing-seam metal over standing-seam metal and asphalt roofing layers. There are six skylights with side gable roofs located along the ridgeline which have been boarded up. The original sliding doors on the side walls have been removed and replaced with paired hinged single-panel metal doors. Single hinged metal single-panel doors have also replaced the wood plank entry doors. On the southeast façade the door openings have been enlarged and front-gabled entries with metal roll-up doors installed during recent renovations. All window opening have been boarded up with plywood panels or had one-over-one vinyl sash windows installed. During the recent renovations the interior of the building was finished with drywall partitions, a second floor was created, and the foundation was reinforced with poured concrete. The original wood plank floor and exposed trusses were not disturbed.

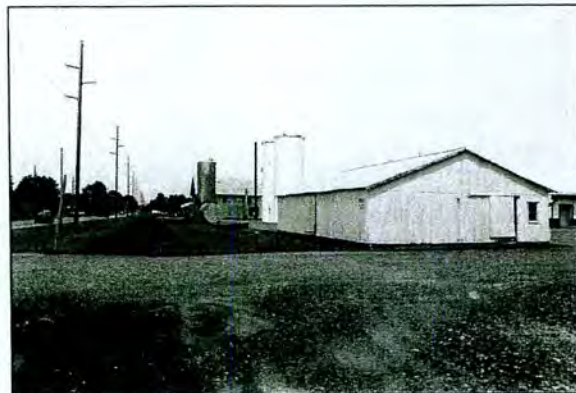
Figure 5-120: Wye Mills Feed Company (T-394) Timber Frame Warehouse

The timber frame warehouse, constructed ca. 1920, is a one-story structure with an undivided interior space (Figure 5-120). The building is six bays deep and rests on a brick pier foundation. The walls are clad with horizontal wood boards over vertical wood boards. The side gable roof is

clad with corrugated metal. The building is accessed through sliding wood plank doors on all façades. There is one six-over-six and one one-over-one wood sash window. The interior was not accessible at the time of the survey.

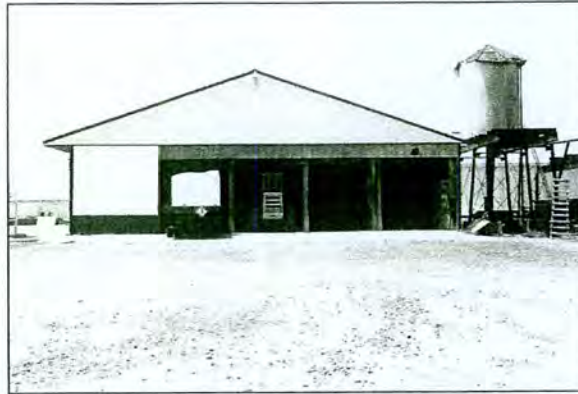
Figure 5-121: Wye Mills Feed Company (T-394) Second Timber Frame Warehouse

The second timber frame warehouse is a one-story structure with the interior divided by wood plank wall into storage bins (Figure 5-121). According to local residents, it is the remains of a three-story cannery building which was torn down with the exception of these remains which were reused as a warehouse building. The building has a modern metal frame addition which was constructed on the northeast façade forming an “L” shape. The walls are clad with corrugated standing-seam metal over vertical wood boards. The cross-gable roof is clad with corrugated standing-seam metal. The building is open on the southeast and southwest façades. There are no doors or windows. The interior was not accessible at the time of the survey. A riveted steel plate water tower is located on a steel frame base within the “L”. The water tank has a hipped roof clad with wood shingles.

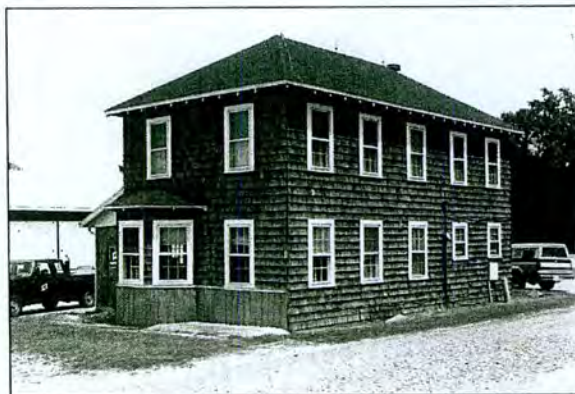
Figure 5-122: Wye Mills Feed Company (T-394) Office

The office is a one-and-a-half story wood frame structure, constructed ca. 1930, with a double pen plan (Figure 5-122). The foundation was not visible. The building is clad with wood shingles. A bay window and vertical wood siding have been added on the northwest façade. The hipped roof is clad with asphalt shingles and has three lightning rods. The building is entered through an offset two panel nine-pane hinged wood door in the enclosed porch. The windows are

six-over-six wood sashes. The building has a metal roof ventilator. The front shed roofed porch has been enclosed with vertical wood board. The interior was not accessible at the time of the survey.

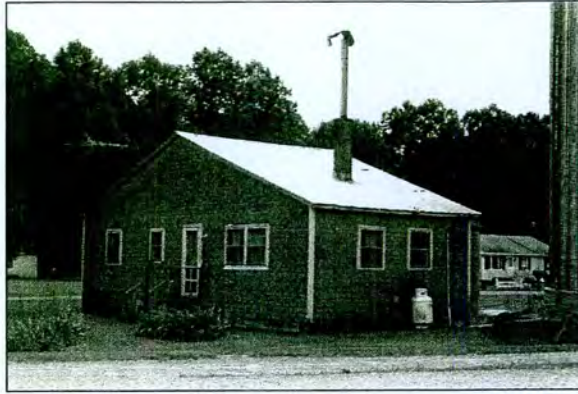
Figure 5-123: Wye Mills Feed Company (T-394) Caretaker's House

The caretaker's house is a one-story wood frame structure with a hall-parlor plan and a rear shed roof addition (Figure 5-123). According to local residents, it was originally part of the ca. 1920 timber frame warehouse which was cut off, moved to this location on the property, and converted into a residence. The building rests on a continuous brick masonry foundation. The building is clad with asphalt shingles. The front-gable roof is clad with corrugated metal. The building is entered through a two panel nine-pane hinged wood entry door. The windows are six-over-six wood sashes. The building has an interior concrete masonry unit chimney. The interior was not accessible at the time of the survey.

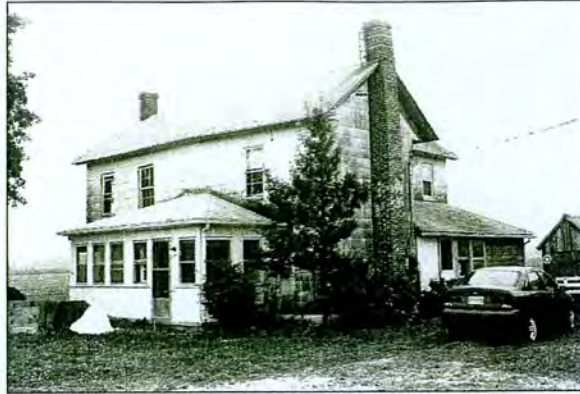
Figure 5-126: Voshell Farm (T-395) Residence

The residence is two-stories tall with three phases of construction (Figure 5-126). The oldest portion of the building was a single-pen log building, constructed ca. 1862. A side addition with a hall and single-pen was constructed ca. 1912, creating a residence with a central hall, single-pile plan. The final phase of additions was constructed ca. 1940 when a single-pen rear ell was constructed with a shed roof porch. The building foundation was not visible. The cross-gable roof is clad with asphalt shingles. The building has an exterior end gable brick masonry chimney and two interior end gable brick masonry chimneys.

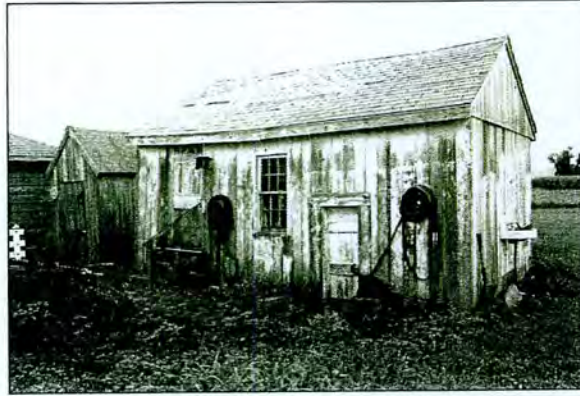
Figure 5-127: Voshell Farm (T-395) Smokehouse (left) and Pump House (right)

The smokehouse, constructed ca. 1915, is a one-story timber frame structure with an undivided interior space (Figure 5-127). The building rests on a dry laid stone masonry foundation. The walls are clad with three inches wide vertical beadboard which is manufactured to appear as 1-1/2-inch wide beadboard from a distance. The front-gable roof is clad with asphalt shingles. The

building is accessed through a hinged wood plank door on the east façade. There are three six-pane wood hopper sash windows, which were added at a later date. The interior of the building is unfinished with a dry laid stone masonry floor.

The pump house, constructed ca. 1955, is a two-story timber frame structure with an undivided interior space (Figure 5-127). The half-buried first floor contains the pump, with storage on the second level. The building rests on a continuous concrete masonry unit and brick foundation. The walls are clad with three inches wide vertical beadboard which is manufactured to appear as 1-1/2-inch wide beadboard from a distance. The side gable roof is clad with asphalt shingles. The first floor of the building is accessed through a hinged wood plank door on the east façade. The second floor is accessed through a four panel four-pane hinged wood door on the east façade. The windows are six-over-six wood sashes. The interior of the building is unfinished with a dry laid stone masonry floor on the first level and a wood plank floor on the second level. The large scale of the building is due to the size of John Voshell, who constructed the building. The building was scaled to accommodate his girth when he went to service the pumps.

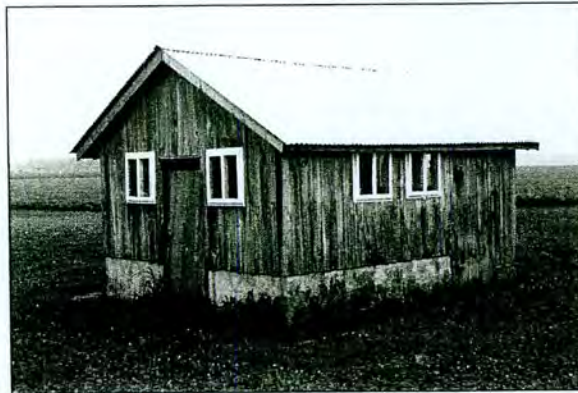
Figure 5-128: Voshell Farm (T-395) Milk House

The ca. 1935 milk house is a one-story light timber frame structure with an undivided interior space (Figure 5-128). The building rests on a poured concrete slab. The walls are clad with three inches wide vertical beadboard which is manufactured to appear as 1-1/2-inch wide beadboard from a distance. The front-gable roof is clad with corrugated metal and has ventilation holes in the gable ends. The building is accessed through a hinged wood plank door on the east façade.

The replacement units are two-pane horizontal vinyl sashes. The interior of the building is finished with a poured concrete floor, beadboard walls, and a beadboard ceiling.

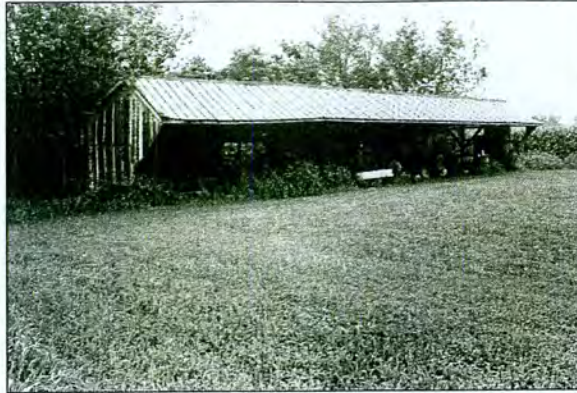
Figure 5-129: Voshell Farm (T-395) Machinery Shed

The machinery shed is five bays wide and is of timber frame construction with an open east façade (Figure 5-129). The shed rests on a combination continuous poured concrete and concrete masonry unit pier foundation. The walls are clad with vertical wood planks. The side gable roof is clad with standing-seam metal. There are no doors or windows. The interior of the building is unfinished with an earthen floor.
